## SERVICE BULLETIN

**APPLICABILITY:** 2019-23MY Ascent

**NUMBER:** 09-107-23

**SUBJECT:** DTC P2404 / Reprogramming Files

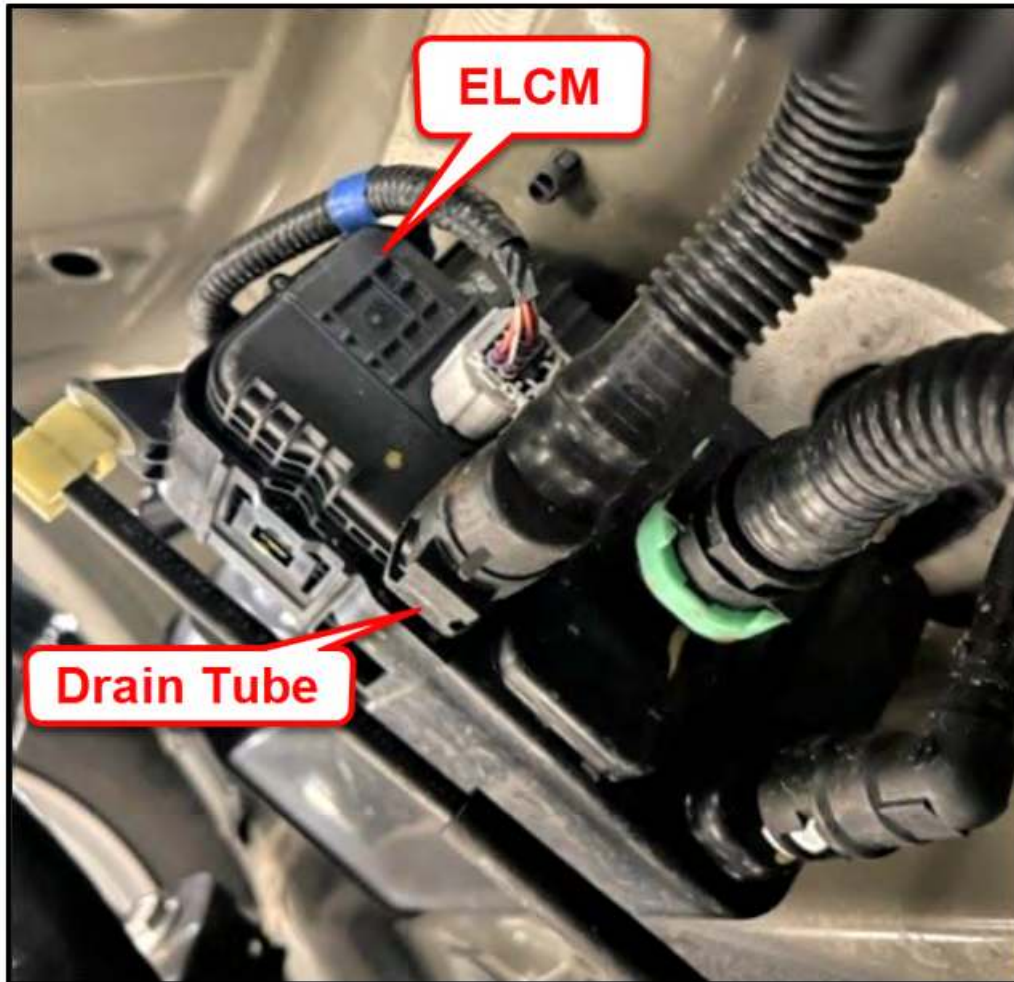
**STEP 5:** **CAREFULLY** disconnect the ELCM drain tube. Inspect for signs of water or oil.

Have signs of water or oil been detected withing the ELCM drain tube?

**YES** – Clean and dry the drain tube using a non-alcohol base cleaner. Proceed to STEP 6.

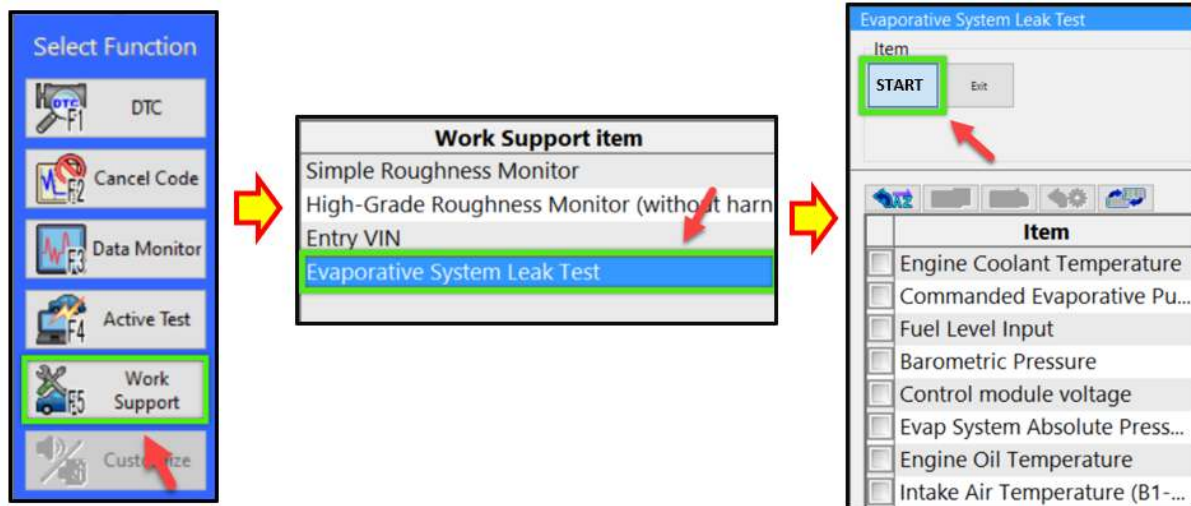
**STEP 6:** Connect the vehicle to a recommended power supply. See **APPENDIX A** for additional information regarding power supply. Using SSM, perform the Evaporative System Leak Test. Collect and save all data.

Once the evaporative system leak test is complete, check the DTCs and examine the vacuum value results. Record the value shown in the row labeled MID: \$3C, TID: \$C4, and Scaling ID: \$FE. This value should be lower than -0.26 PSI.

Value Must Be Lower Than -0.26 PSI

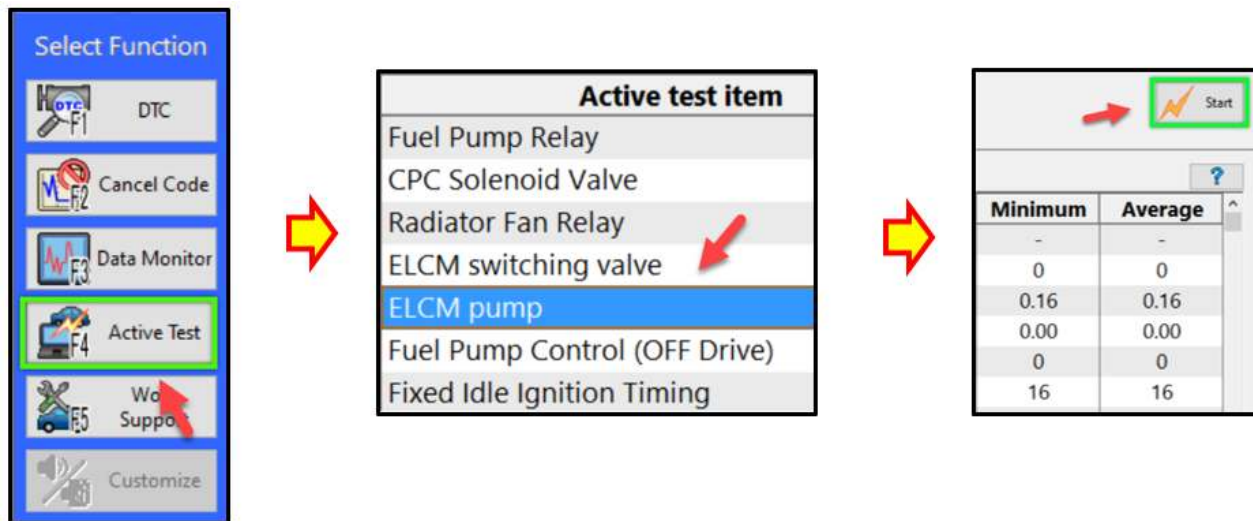
**STEP 8:** Using SSM, perform the ELCM Pump Active Test for a period of 35 minutes or more. See **APPENDIX A** for additional information regarding power supply.

Once the ELCM Pump Active Test has been performed for a period of 35 minutes or more, repeat the Evaporative System Leak Test outlined in STEP 6. Check the DTCs and the vacuum value results.
