## SERVICE BULLETIN

**APPLICABILITY:** 2020-23MY Legacy & Outback 2.4L  
2023MY Legacy & Outback 2.5L

**NUMBER:** 09-108-23

**SUBJECT:** DTC P2404 / Reprogramming Files

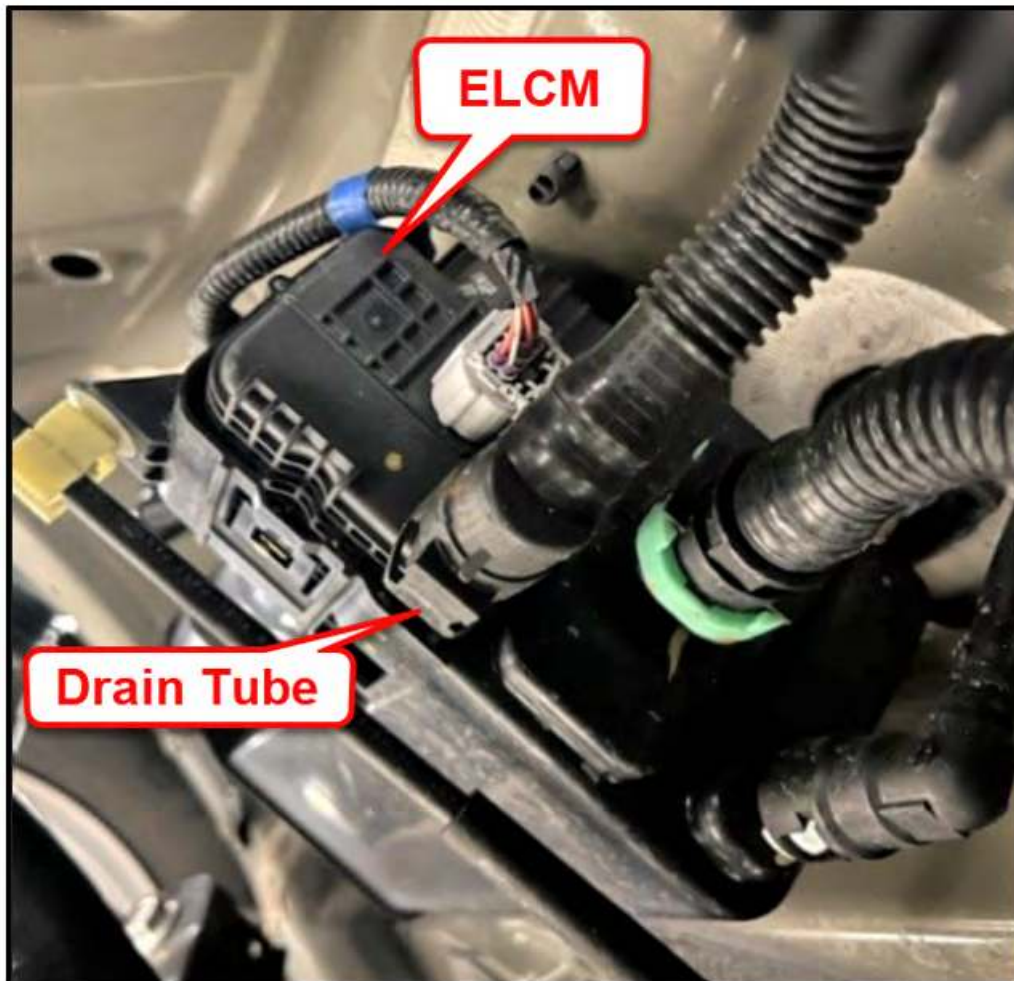
**STEP 5:** **CAREFULLY** disconnect the ELCM drain tube. Inspect for signs of water or oil.

Have signs of water or oil been detected withing the ELCM drain tube?

**YES** – Clean and dry the drain tube using a non-alcohol base cleaner. Proceed to STEP 6.

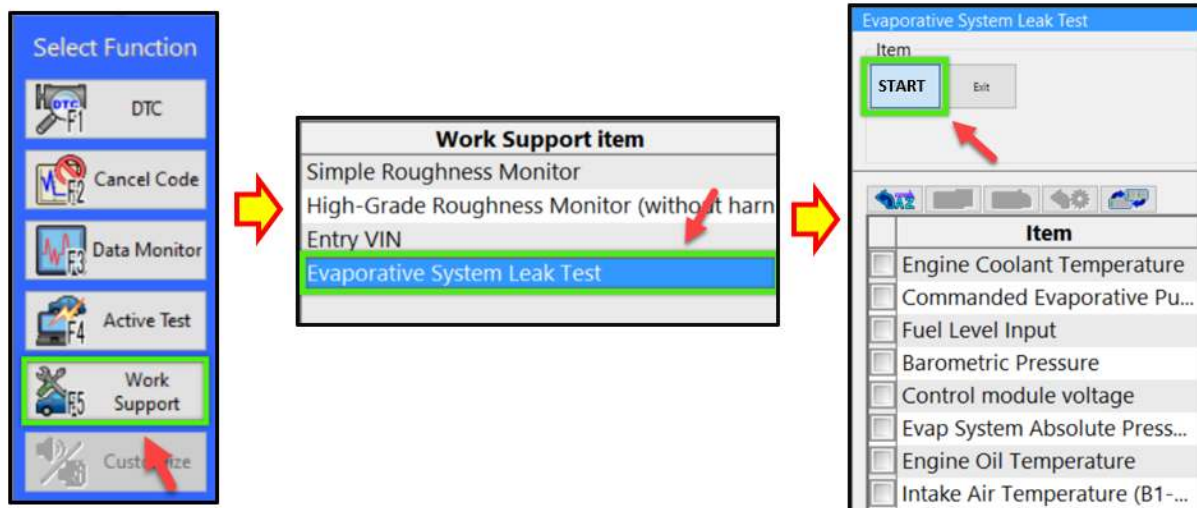
Once the evaporative system leak test is complete, check the DTCs and examine the vacuum value results. Record the value shown in the row labeled MID: \$3C, TID: \$C4, and Scaling ID: \$FE. This value should be lower than -0.26 PSI.

Value Must Be Lower Than -0.26 PSI

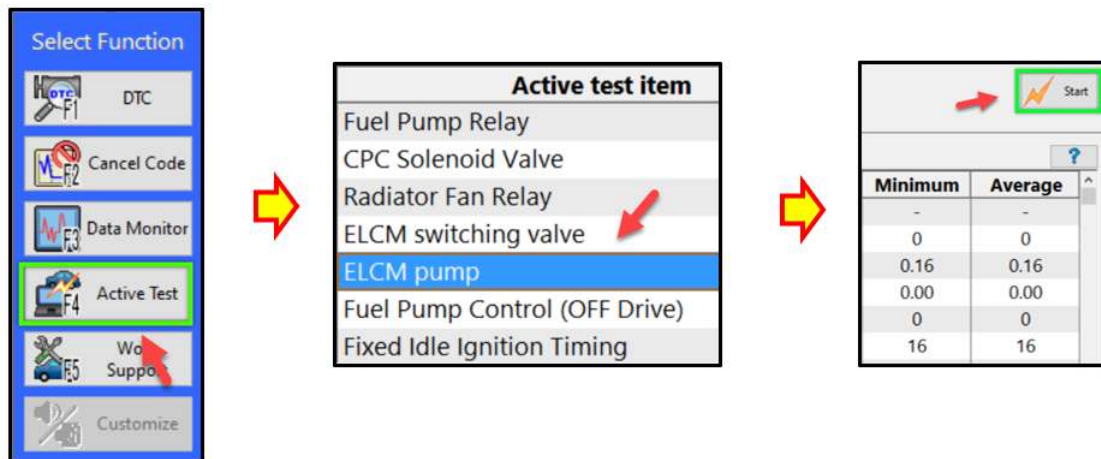
**STEP 8:** Using SSM, perform the ELCM Pump Active Test for a period of 35 minutes or more. See **APPENDIX A** for additional information regarding power supply.

Once the ELCM Pump Active Test has been performed for a period of 35 minutes or more, repeat the Evaporative System Leak Test outlined in STEP 6. Check the DTCs and the vacuum value results.
