**Technical Service Bulletin (TSB)**  
**Headlamps or Front Turn Signals Inoperable**

| REFERENCE: | TSB: 23-062-23<br>GROUP 23 - Body | Date: | June 3, 2023 | REVISION: | – |
| VEHICLES AFFECTED: | 2022 - 2023 (H1) Jeep Commander<br>This bulletin applies to vehicles built on or after September 01, 2022 (MDH 0901XX) and on or before May 10, 2023 (MDH 0510XX). | | | MARKET APPLICABILITY:<br><input type="checkbox"/> NA<br><input checked="" type="checkbox"/> SA<br><input type="checkbox"/> EE<br><input type="checkbox"/> MEA<br><input type="checkbox"/> IAP<br><input type="checkbox"/> CH | |

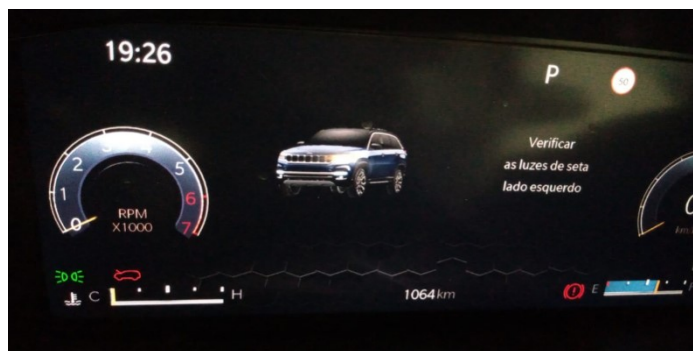
**Fig. 1**  
**IPC Message**

| CUSTOMER SYMPTOM: | Customers may experience a Malfunction Indicator Lamp (MIL) illumination. Upon further investigation the technician may find that the one or more of the following Diagnostic Trouble Codes (DTCs) have been set: <ul style="list-style-type: none"><li>• B1749-11 - FLLU Turn Light Feedback Left.</li><li>• B1749-15 - FLLU Turn Light Feedback Left.</li><li>• B1749-96 - FLLU Turn Light Feedback Left.</li><li>• B1750-11 - FRLU Turn Light Feedback Right.</li><li>• B1750-15 - FRLU Turn Light Feedback Right.</li><li>• B1750-64 - FRLU Turn Light Feedback Right.</li></ul> The customer may also comment on the following:<br>One or both headlamps or front turn signals, are inoperable.<br><b>NOTE:</b> A message in the Instrument Panel Cluster (IPC) may also be displayed (Fig. 1) . | | | | |
| CAUSE: | Headlamp assembly malfunction. | | | | |

1. Replace the affected headlamp assembly as required. Refer to the detailed service procedures available in DealerCONNECT/Service Library under: Service Info> 08 - Electrical / 8L - Lamps and Lighting / Lamps/Lighting - Exterior / unit, Front Lamp / Removal and Installation.
2. Clear all DTCs that may have been set.
