## Technical Service Bulletin (TSB)

### Turbo to Charge Air Cooler Quick Connect Loose

| REFERENCE: | TSB: 09-011-23<br>GROUP 09 - Engine | Date: | June 8, 2023 | REVISION: | – |
| VEHICLES AFFECTED: | 2022 - 2023 (WS) Grand Wagoneer/Wagoneer<br>This bulletin applies to vehicles built on or after August 25, 2022 (MDH 0825XX) and on or before February 17, 2023 (MDH 0217XX) equipped with a 3.0L I6 Hurricane HO Twin Turbo ESS (Sales Code EFC). | | | MARKET APPLICABILITY:<br><input checked="" type="checkbox"/> NA<br><input type="checkbox"/> SA<br><input type="checkbox"/> EE<br><input type="checkbox"/> MEA<br><input type="checkbox"/> IAP<br><input type="checkbox"/> CH | |

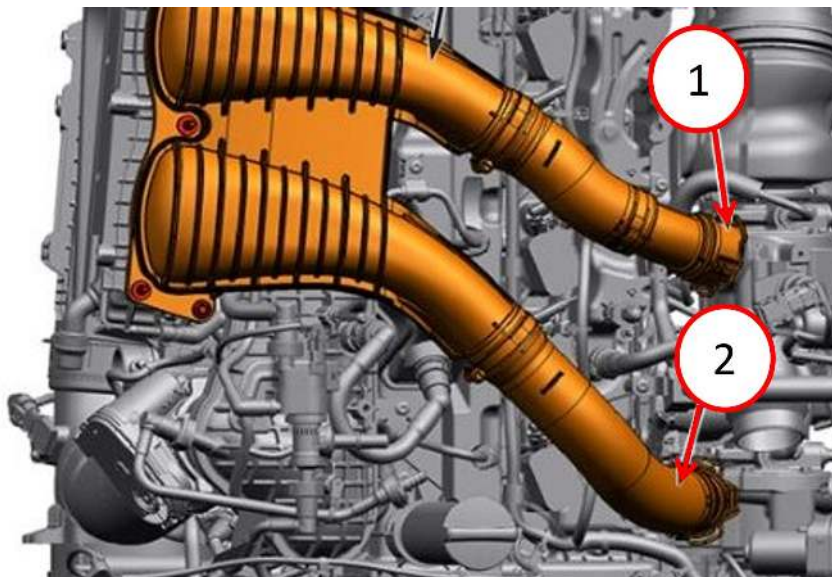
**Fig. 2**  
**Front And Rear Turbo CAC Inlet Tubes**

- 1 - Rear Turbo CAC Inlet Tube
  - 2 - Front Turbo CAC Inlet Tube (Confirm With A Push-Pull-Push Test)
-

2. Lift up and remove the engine cover (Fig. 1) .
3. Confirm with a push-pull-push test that the charge pipe from the front/forward turbo to the Cold Air Cooler (CAC) (Fig. 2) , is fully secured at the turbo and the quick connect is locked (Fig. 3) . **The following are examples of CACs that are not fully secure: (Fig. 4) and (Fig. 5) .**

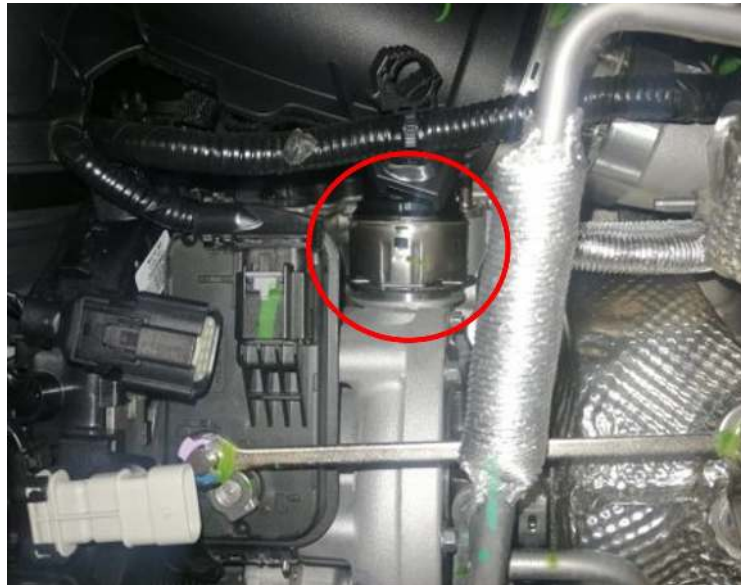
**Fig. 3**  
**Fully Secured And Locked Quick Connect**

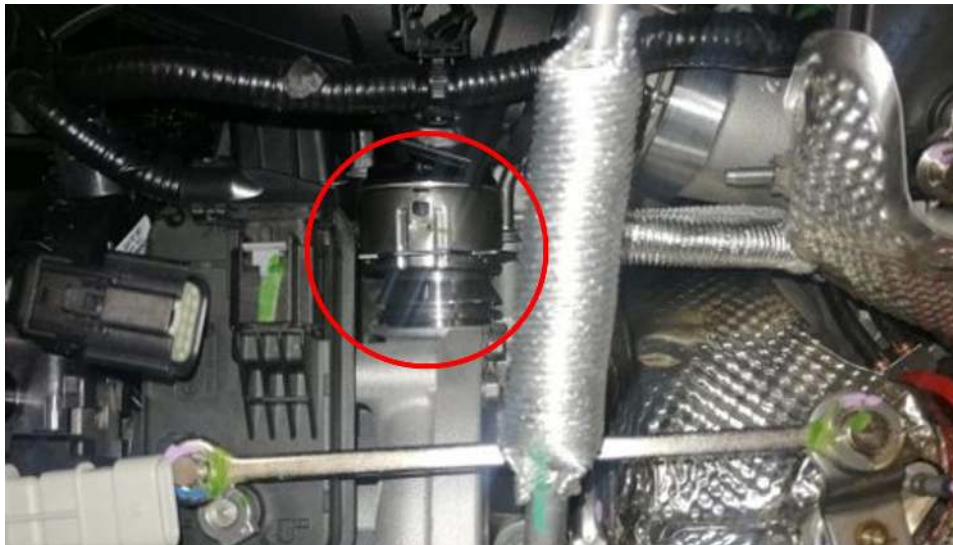
| CAUSE: | Charge air cooler quick connect. | | | | |

**Fig. 4**  
**Quick Connect Completely Disconnected**

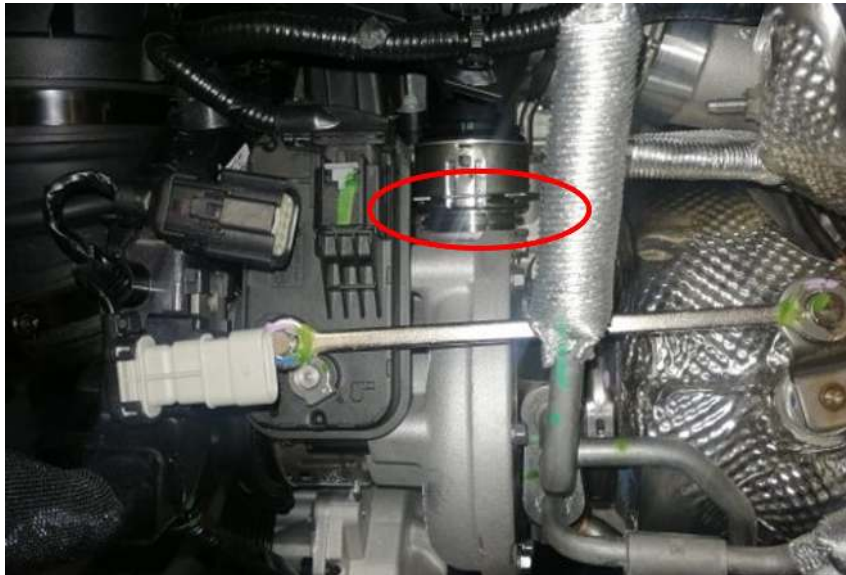
**Fig. 5**  
**Quick Connect Not Fully Seated**

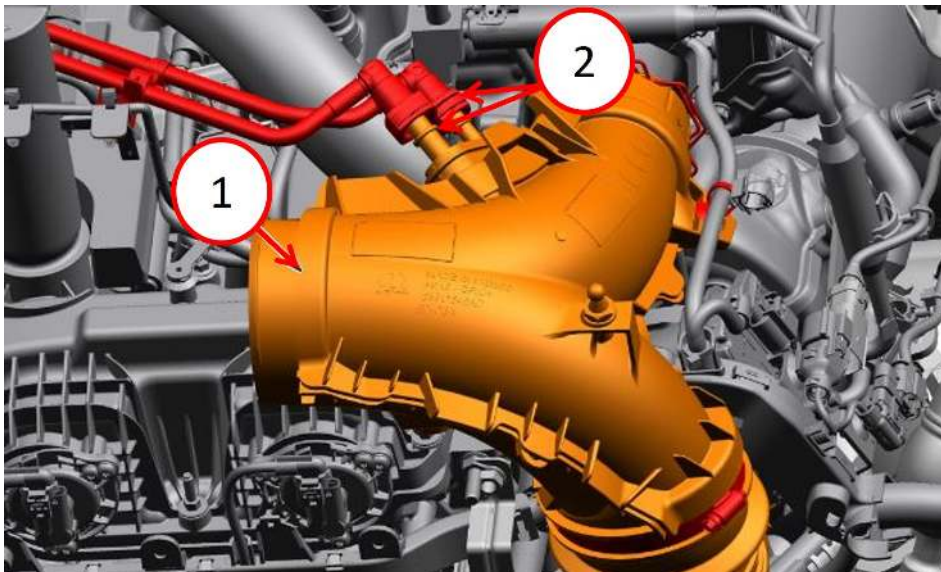
**Fig. 6**  
**Purge Hoses At Intake Air “Y” Tube**

- 1 - Intake Air “Y” Tube
- 2 - Purge Hoses

4. Confirm with a push-pull-push test that both purge hoses at the intake air “Y” tube (Fig. 6) , are fully secured at the intake air “Y” tube and the quick connects are locked .
