## Technical Service Bulletin (TSB)

### Stop/Start Disabled

| REFERENCE: | TSB: 08-138-23<br>GROUP 08 - Electrical | Date: | June 9, 2023 | REVISION: | – |
| VEHICLES AFFECTED: | 2022 - 2023 (WS) Grand Wagoneer/Wagoneer<br>This bulletin applies to vehicles built on or after August 24, 2022 (MDH 0824XX) and built on or before March 08, 2023 (MDH 0308XX). | | | MARKET APPLICABILITY:<br><input checked="" type="checkbox"/> NA<br><input type="checkbox"/> SA<br><input type="checkbox"/> EE<br><input type="checkbox"/> MEA<br><input type="checkbox"/> IAP<br><input type="checkbox"/> CH | |

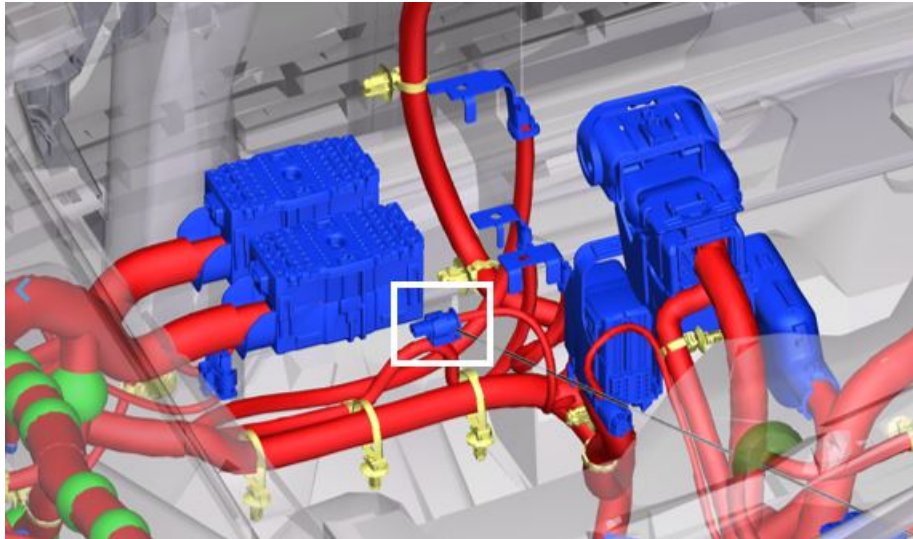
1. Remove the Power Distribution Center (PDC) in the engine compartment. Refer to the detailed procedures available in DealerCONNECT > Service Library> under: 08 - Electrical / 8W - Power Distribution / Center, Power Distribution (PDC) / Removal .
2. Locate connector D3157A ([Fig. 1](#)) .

**Fig. 1**  
**Location of D3157A**

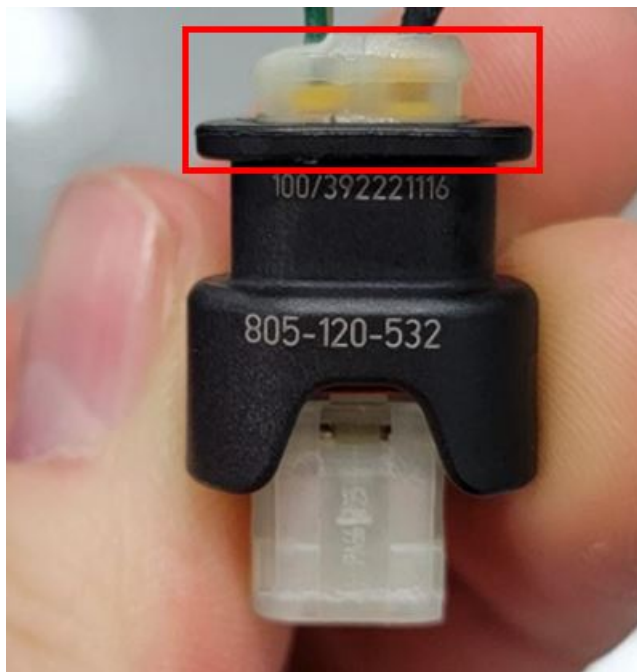
| CAUSE: | Connector not fully seated. | | | | |

**Fig. 3**  
**Connector (D3157A) Not Fully Seated**

5. If not properly seated and/or not connected to the PDC, properly reconnect D3157a to the PDC (Fig. 3) .
