# Technical Bulletin

| Model(s) | Year(s) | Eng. Code(s) | Trans. Code(s) | VIN Range From | VIN Range To |
|---|---|---|---|---|---|
| Touareg,<br>Touareg 2 | 2007-2009 | 3.6L<br>(BHK) | All | 7L_7D000001 | 7L_9D017949 |

01 14 05 February 21, 2014 2019434 Supersedes T.B. V011206 dated March 14, 2012 to correct Technical Diagnosis labor operation coding in the warranty table.

MIL ON, DTCs P0325 or P0327 Stored in ECM Fault Memory

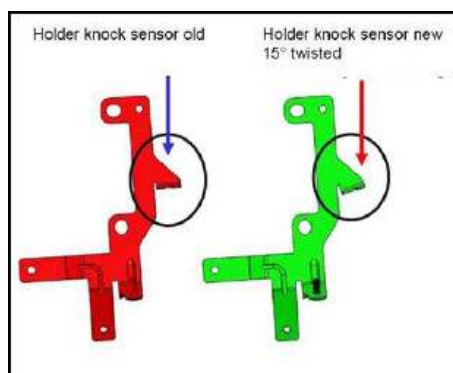
Figure 1

The condition is caused by humidity entering the knock sensor or its cable.

1. Replace knock sensor -G61- with wiring harness 03H 905 377A.
2. Tighten the mounting bolt of knock sensors to 20 Nm (177 in. lbs.).

- Inspect whether or not knock sensor bracket Part No. 03H 971 501 D (the new knock sensor bracket that is twisted 15°) is installed.

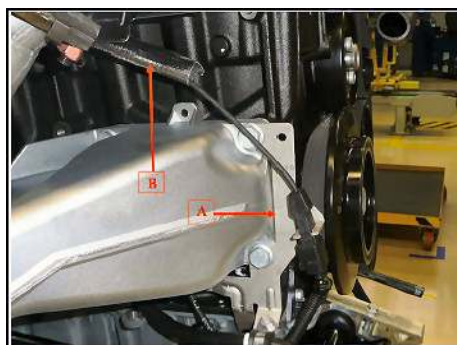
Figure 2

If the old knock sensor bracket 03H 971 501 A is installed:

- Replace with the new bracket Part No. 03H 971 501 D (Figure 2, inset A).
