# Technical Bulletin

15 14 01 March 11, 2014 2015153 Supersedes T. B. V151202 dated August 20, 2012 to update technical diagnosis labor operation in warranty table and update the Intake camshaft suffix number.

### MIL ON, DTC P0087, P1093 or P2293 Stored in ECM Fault Memory

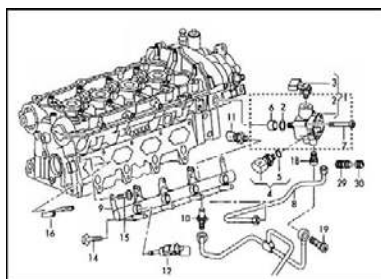
Figure 1

Remove the high pressure fuel pump and visually inspect:

1. Base surface of the cam follower -6- in contact with the camshaft lobe.
2. Tip of the high pressure fuel pump plunger.

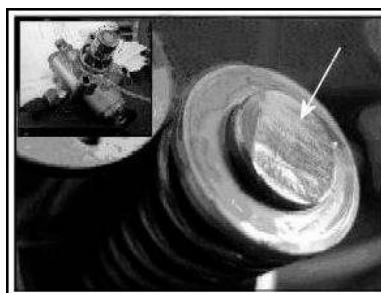
Figure 2

Inspect the tip of the high pressure fuel pump plunger (Figure 2) for excessive wear.

High pressure fuel pump plunger damage is only possible if the cam follower base has a hole in it as seen in figure 3 inset -A-, and the plunger tip has come in direct contact with the camshaft lobe (figure 4).

If plunger tip of fuel pump is **NOT WORN**, **DO NOT REPLACE** the fuel pump.

If excessive wear is found the high pressure pump must also be replaced, see Group 20 Fuel Supply in ElsaWeb.
