## Technical Service Bulletin (TSB)

### Service Air Suspension Message On

| REFERENCE: | TSB: 02-006-23<br>GROUP 02 - Front Suspension | Date: | August 19, 2023 | REVISION: | – |
| VEHICLES AFFECTED: | 2023 (WL) Jeep Grand Cherokee<br>This bulletin applies to vehicles built on or before May 16, 2023 (MDH 0516XX) equipped with Quadra-Lift Air Suspension (Sales Code SER). | | | MARKET APPLICABILITY:<br><input checked="" type="checkbox"/> NA <input type="checkbox"/> CH<br><input type="checkbox"/> EE <input type="checkbox"/> IAP<br><input type="checkbox"/> SA <input checked="" type="checkbox"/> MEA | |

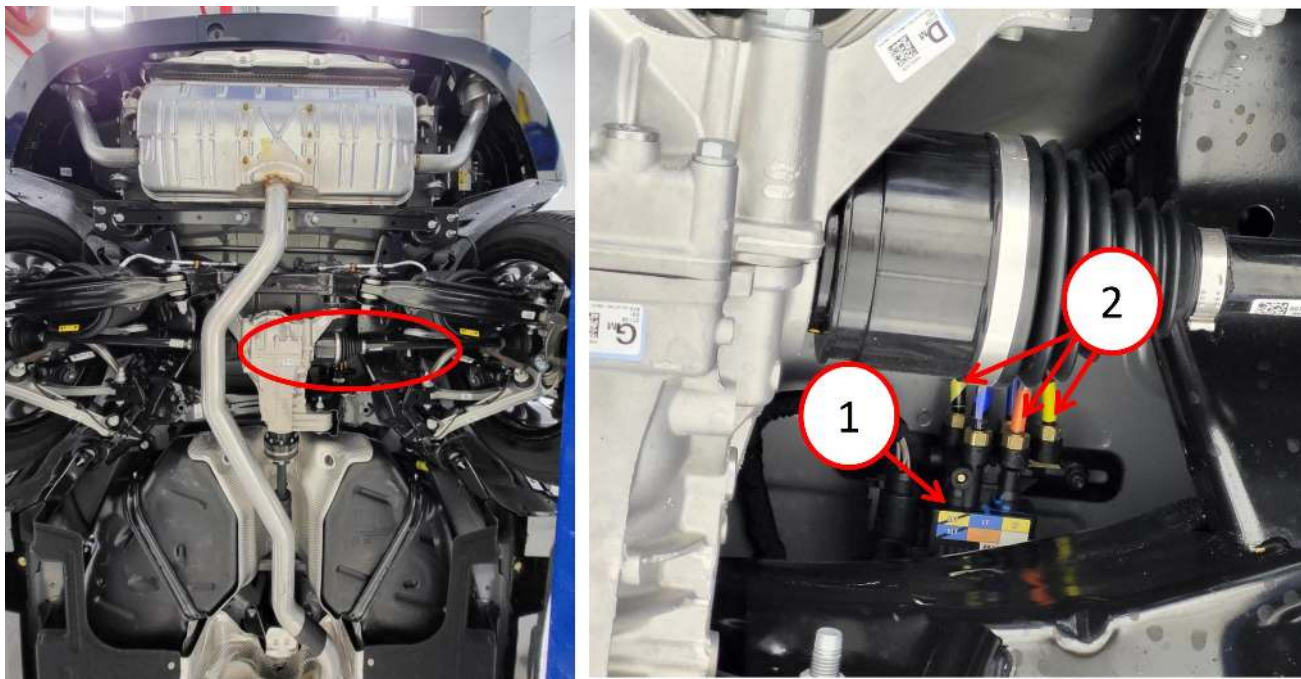
**Fig. 1**  
**Fast Down Leveling Valve And Air Lines**

| CAUSE: | Air line(s) may not be fully seated. | | | | |

1. Hoist vehicle. Raise and support the vehicle. Refer to the detailed service procedures available in DealerCONNECT/Service Library under: Service Info>04 - Vehicle Quick Reference / Hoisting / Standard Procedure.
2. Visually confirm the air lines are fully bottomed out in the fast down leveling valve up to the colored tape (Fig. 1) .

3. Were any air lines not fully bottomed out in the fast down leveling valve and up to the colored tape (Fig. 1) ?
  - YES>>> Proceed to [Step 1](#) of the Repair Procedure.
  - NO>>>This bulletin does not apply. Normal diagnosis should be performed. Use inspect LOP (02-66-01-9A) to close the active RSU.

1. Push all five air lines into the fast down leveling valve and up to the colored tape (Fig. 1) .
2. Confirm all five air lines are seated with a push-pull-push test.
3. Clear any DTCs that may have been set.
