# Technical product information

| Topic | Knocking noise from the front and/or rear - DTC C1298F1 evident within D4 and/or D5 |
| Brand | Bentley |
| Transaction No. | 2065085/3 |

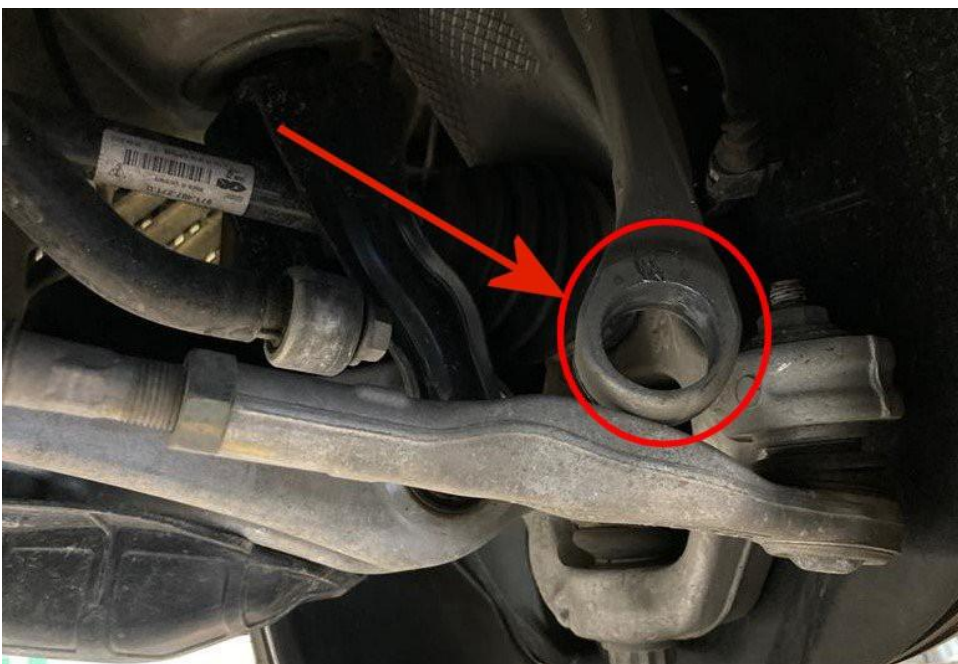
Figure 1

NOTE: The photo shown within this TPI is of the front anti roll bar drop link, please note the issue can also be evident on the rear

1) Check the front and/or rear anti roll bar drop link has not detached (Figure 1) in this scenario DTC (C1298F1: Suspension stabilization actuator Regulation not possible) may be evident within address D4 and/or D5

Check for signs of impact on or around the affected components, ensure photographic evidence of the issues found are attached to a new or already open DISS query to support all warranty claims

3) Raise a DISS query ensuring any photos and videos are attached of the issues found NOTE: The operative does not have to wait for a response before replacing parts - Referring to the applicable Rep.Gr - Replace the applicable drop link
