# Technical product information

| Topic | DTC B101C29 and/or DTC B101D29 evident within the airbag control unit (J234) |
| Brand | Bentley |
| Transaction No. | 2071047/2 |

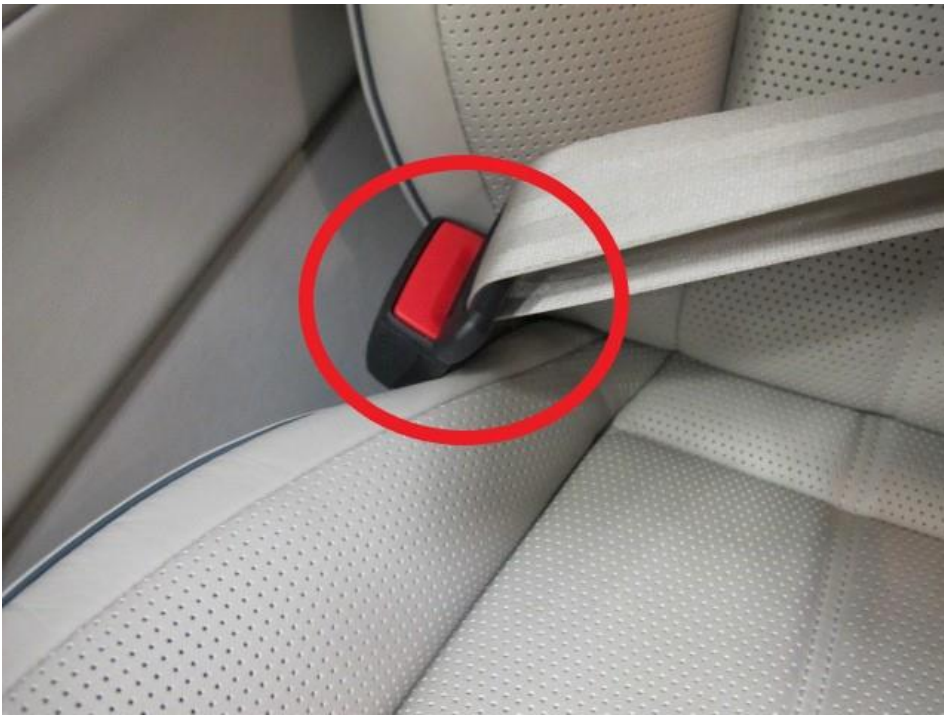
Figure 1

- 1) Insert the drivers side seatbelt tongue into the seatbelt buckle (Figure 1)
- 2) Referring to TPI 2071131/- Measured values - Cycle recording instructions - Record MVB IDE01193 (Drivers side) whilst manoeuvring the seatbelt buckle assembly - *Reference the Bentley Hub TPI 2071047/- (Video 1)*

6) With the tongue inserted into the buckle (Figure 1) measure and record the resistance of the drivers side seatbelt buckle using a suitable multimeter

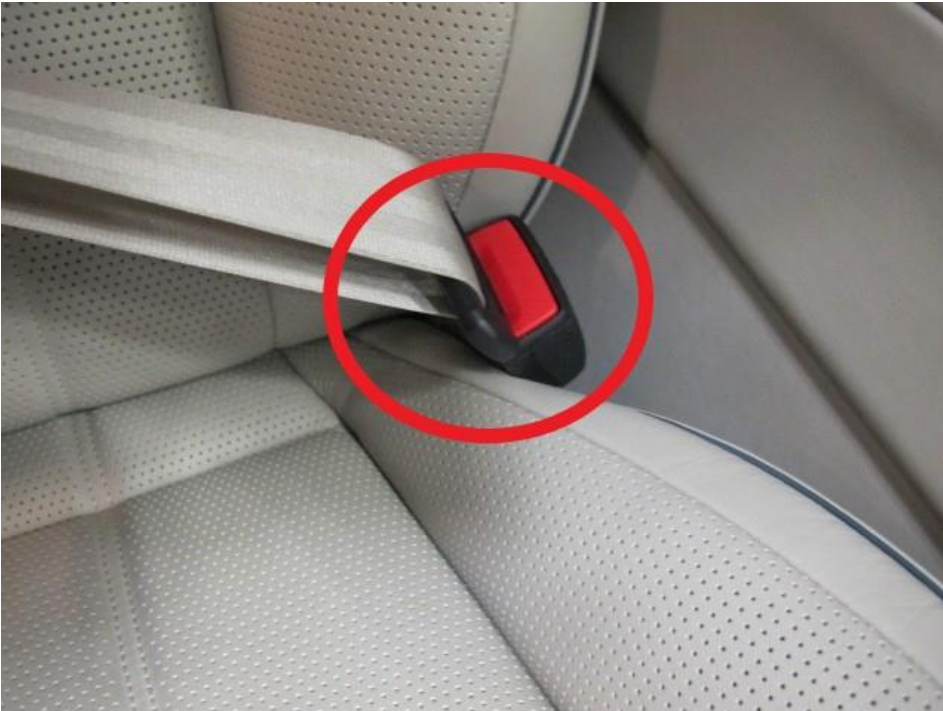
- 1) Referring to Figure 4 - Insert the passenger side seatbelt tongue into the seatbelt buckle
- 2) Referring to TPI 2071131/- Measured values - Cycle recording instructions - Record MVB IDE01194 (passenger side) whilst manoeuvring the seatbelt buckle assembly - *Reference the Bentley Hub TPI 2071047/- (Video 1)*

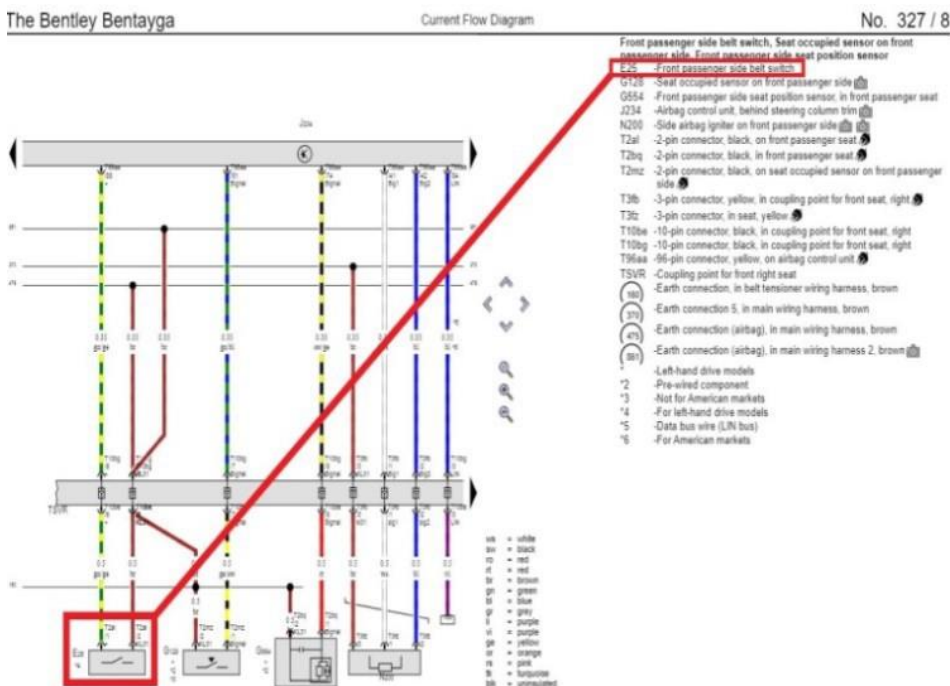
Figure 5

- 3) Referring to TPI 2071131/- Measured values - Cycle recording instructions - Record MVB IDE01194 (passenger side) whilst installing and removing the seatbelt tongue from the buckle the seatbelt buckle assembly - *Reference the Bentley Hub TPI 2071047/- (Video 2)*
- 4) Referring to the applicable wiring diagram/Figure 5 - Locate E25

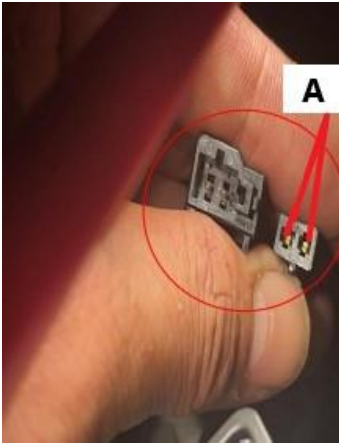
- 5) Referring to Figure 6 - Disconnect the E25 connection (circle)
