| <b>Topic</b> | New Continental GT and GTC - Window drop glass operation |
| <b>Transaction No.</b> | 2070497/5 |

Retailer glass reset procedure for GT/GTC

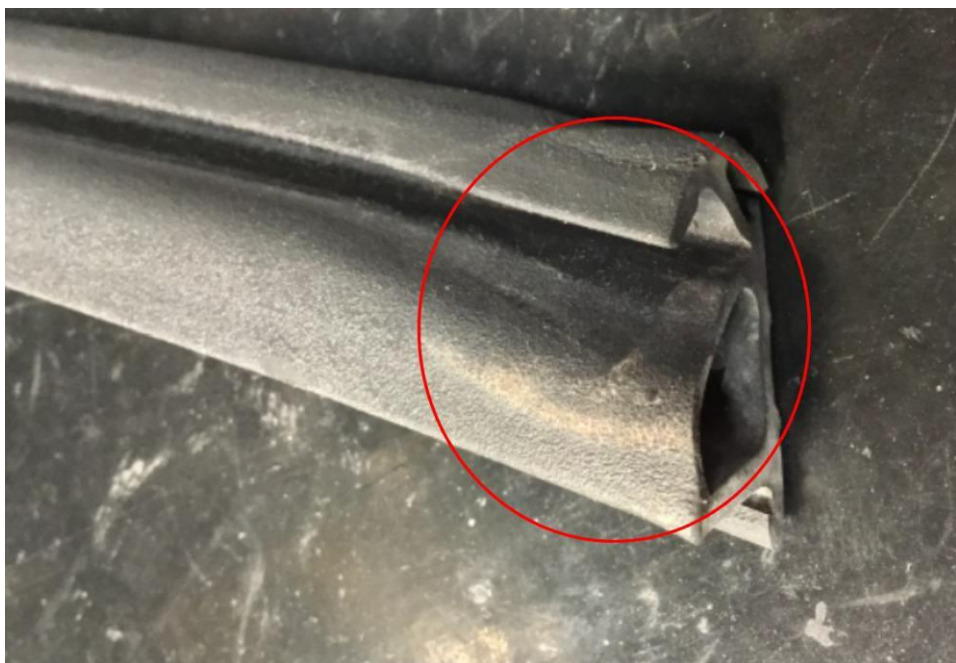
Figure 9

- Damage
- Splits
- Tears
- Misalignment
- Incorrectly fitted/located
- Drop glass seal deformation (see Figures 9 and 10 as examples)

NOTE: Any issues found with the window seals must be rectified before conducting the remaining steps

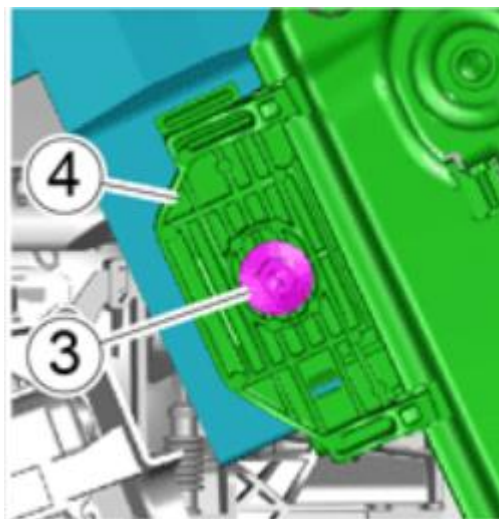
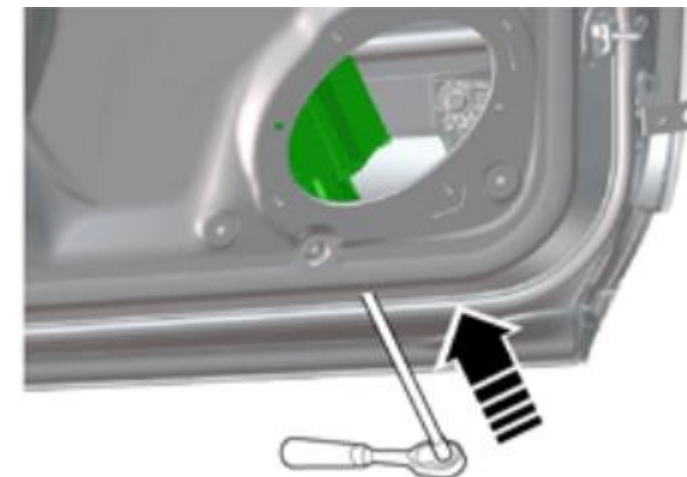
Example: Front drop glass Z axis not adjusted correctly. Bottom of tape was level with waist rail seal, after slackening pinch bolt (3 in bottom left image) front drop glass lowered 14mm to where pen marked line is.

Z-axis adjusters (bottom middle and right images) had not been used, pinch bolt had been slacked and glass lifted out of the regulator to achieve specification. This has a knock on effect of altering the 10mm division bar intrusion seen in previous slide as glass is loose and can be accidentally moved in X-axis.

This also creates a risk that the window will bottom out on the cant rail seals rather than the regulator bump stops meaning that the glass can raise further as the seals soften over time and affect end stop learning.

## Z-Axis height should only be adjusted by the 4mm Allen key adjusters as per ELSAPRO

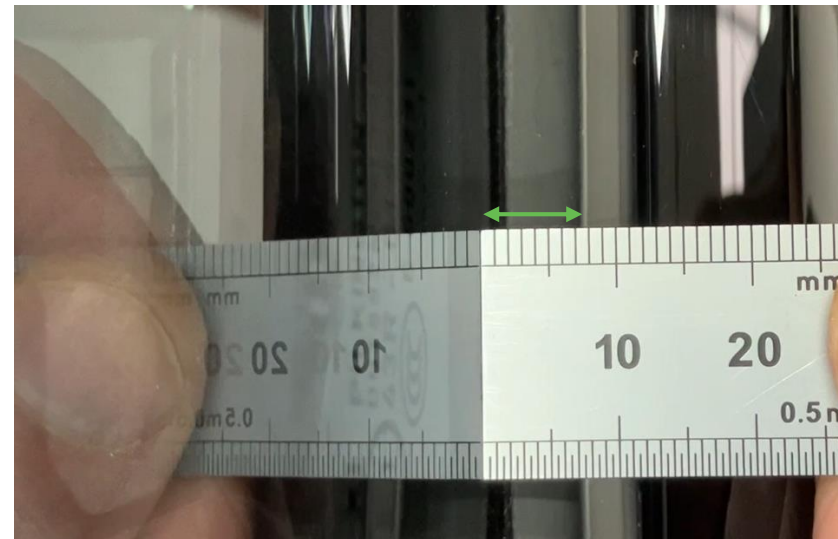
RHF window, front window closed, rear window closed. Note gap, over 0.25mm outboard movement, this is incorrect

If more tension is required to resolve a wind noise or water ingress then aim for no more than 0.25mm of outboard movement.

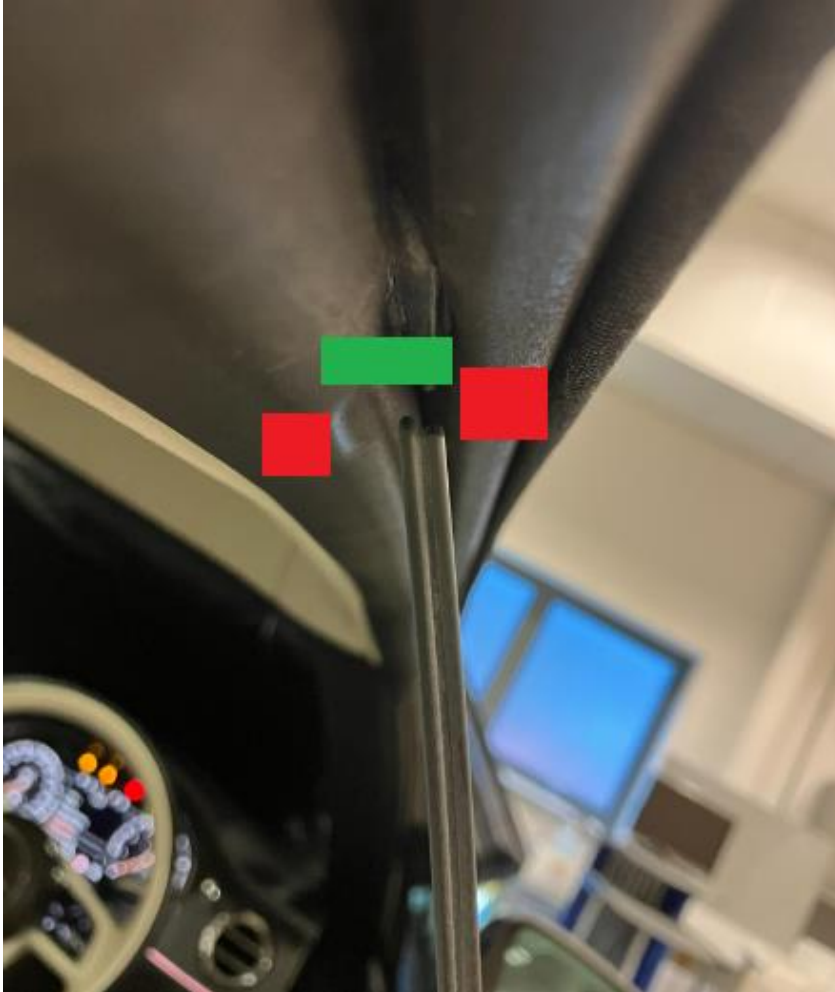
Windows should enter cant rail seal smoothly, making contact with inboard edge first and then be pushed outboard (green square).

Too far inboard increases the risk of the cant rail seal pinching, too far outboard will clash with cant rail brightware (red squares). For front door, poor door profile is a major contributing factor here and should be checked/adjusted if window found to be entering seal incorrectly.
