# Service Bulletin

Bulletin No.: 11-06-04-007C

Date: November, 2012

**Subject:** Diagnosis and Repair - Malfunction Indicator Lamp (MIL) Illuminated, Reduced Engine Power Message Displayed, DTC P2135 Set

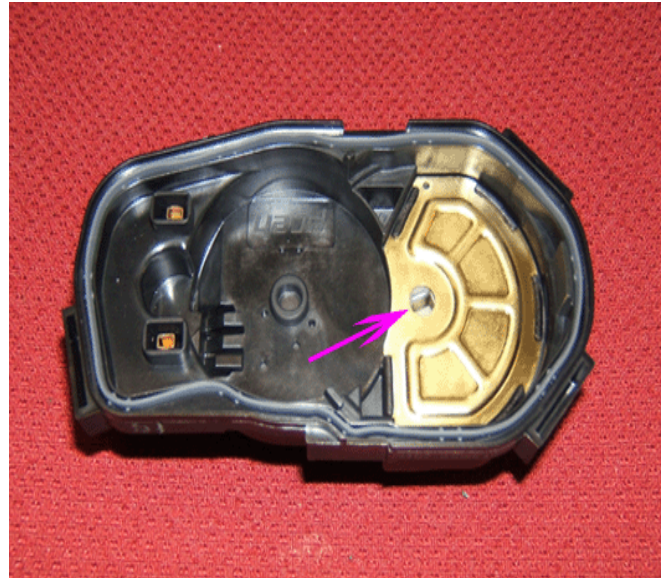
14. Observe the TP sensor cover for missing female throttle actuator motor terminals (1). Verify that the female throttle actuator motor terminals HAVE REMAINED in the TP sensor cover and HAVE NOT been retained on the throttle actuator motor male terminals (2). Discard the old TP sensor cover, gasket and terminals.

⇒ If one or both of the TP sensor cover female throttle actuator motor terminals HAVE BEEN retained on the throttle actuator motor male terminals (2), remove and discard those female terminals.
