# Service Bulletin

Bulletin No.: PIT5278B

**Subject:** Power Liftgate Erratic Operation Will Not Power Close DTC B153A And/Or Motor Running But Does Not Move

**Models:** 2015 Cadillac Escalade Models  
2015 Chevrolet Tahoe, Suburban  
2015 GMC Yukon Models

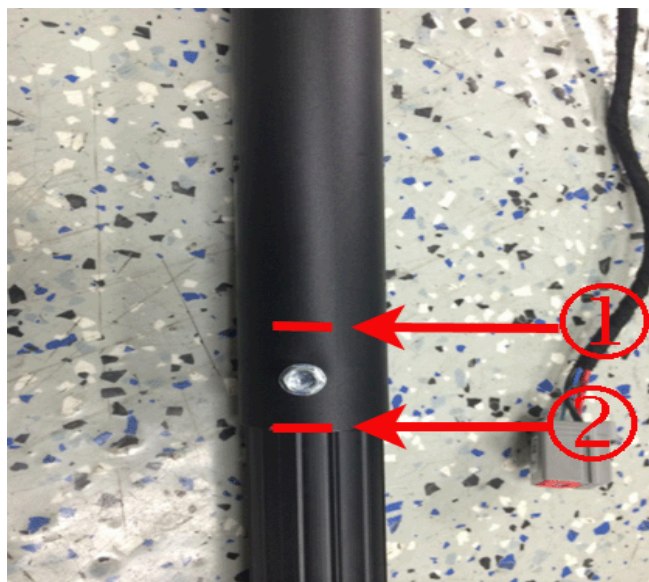
3825800

These concerns may occur if the left liftgate strut/motor actuator is internally coming apart. It will need to be replaced, but care must be taken when removing the left liftgate strut/motor actuator from the vehicle. There is an assist spring inside the strut. If the internal portion of the strut has completely separated, and if it is removed from the vehicle without following the procedure listed below, the end of the strut can become a projectile.

1. Obtain one #8 self-tapping screw 1 1/2 inches long.
2. Fully open the liftgate.
3. Install the self-tapping screw any place in the 30 mm space (from the bottom of the smooth tube) between location 1 and 2. As reflected below, a location of 20 mm (approximately 3/4") is ideal to secure the tubes.

**Note:** The screw will hold the strut together for removal.
