# Service Bulletin

Bulletin No.: 15-NA-084

**Subject:** Diagnostic Tips for Engine Running Rough, Poor Acceleration, Smell of Exhaust Inside Cabin, Possible P0101, P0299, P2002, P2263 or P2463 DTCs Set

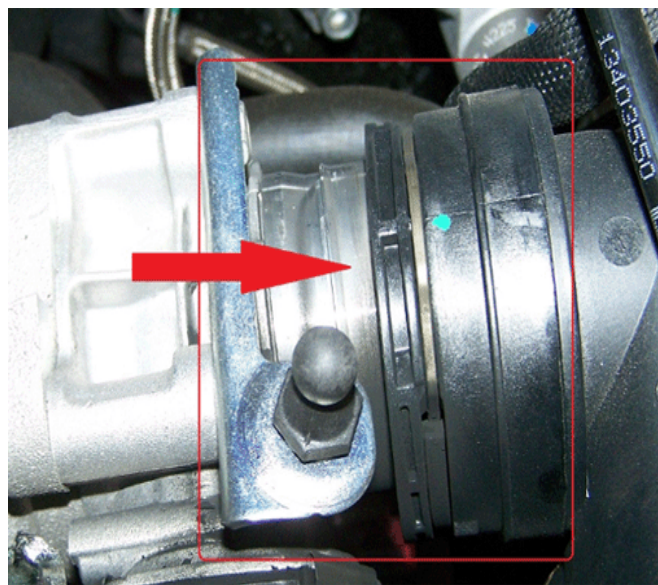
4335262

Visually inspect to see if the charge air cooler (CAC) duct has become disconnected from the throttle body.

If the charge air cooler duct has become disengaged, complete the following:

- Replace the charge air cooler duct with a new one. Refer to the proper replacement procedure in SI.

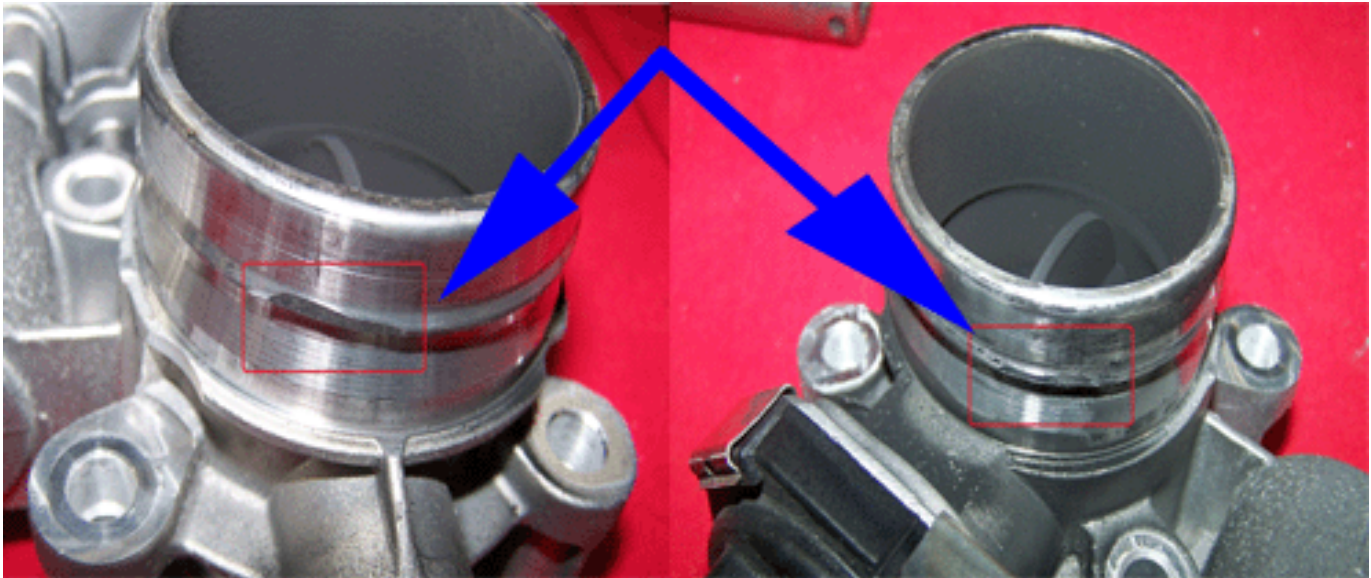
4335267

- Visually inspect for throttle body damage.
