Bulletin No.: 16-NA-013

# Service Bulletin

**Subject:** No Reverse, No Third, DTC P0716, P0717

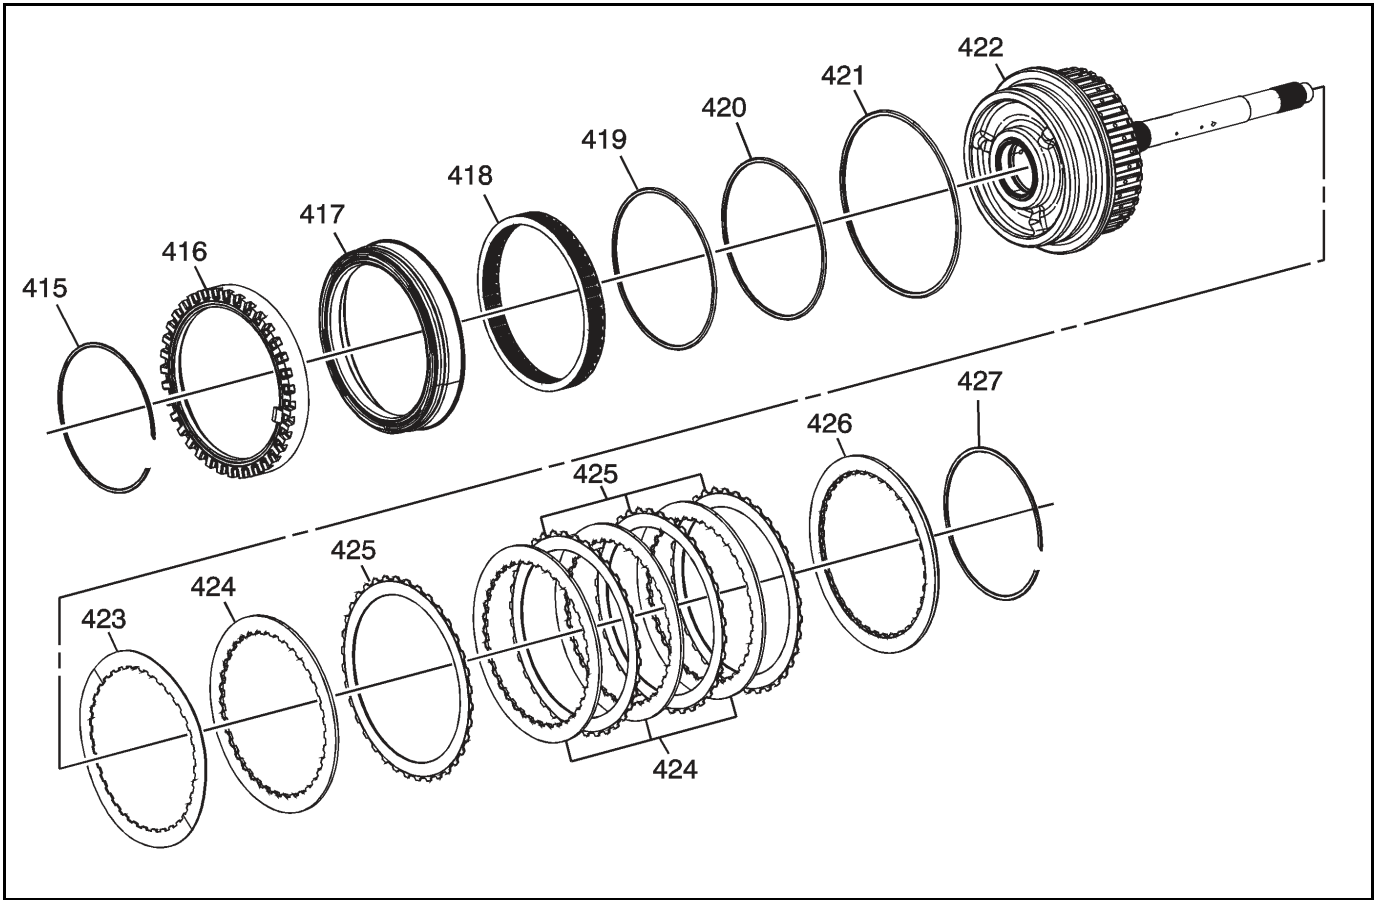
1725896

| <b>Cause</b> | This condition may be caused by the Input Shaft Speed Sensor Reluctor Ring Retainer Ring being out of the groove. |

Replacement of the Retainer Ring (415), Input Shaft Speed Sensor Reluctor Wheel (416), 3-5-Reverse Clutch Piston (417) and 3-5-Reverse and 4-5-6 Clutch Housing Assembly (422). Inspect and replace other distressed parts as needed.
