# Service Bulletin

Bulletin No.: 16-NA-020

**Subject:** Turbocharger Noise and/or Malfunction Indicator Lamp Illuminated with DTC P2261

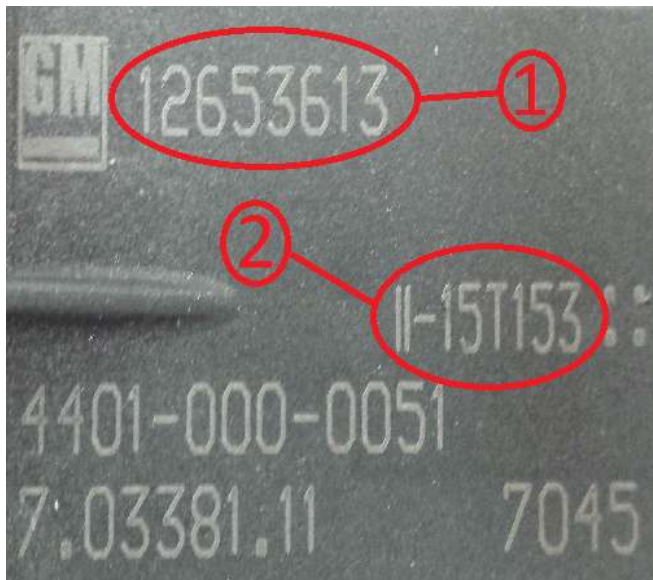
4367888

| <b>Condition</b> | Some customers may comment that the turbocharger is noisy and/or the malfunction indicator lamp is illuminated with DTC P2261. |
| <b>Cause</b> | This may be caused by a stuck turbocharger bypass valve. |

If diagnosis does not lead to an electrical concern, check the Julian date (2) on the turbocharger bypass valve.

- If prior to Julian date 15T327, replace the turbocharger bypass valve per SI repair procedure.
- If the Julian date is 15T327 and after, refer to SI diagnostics.
