# Service Bulletin

Bulletin No.: 09-07-30-012F

**Subject:** No Reverse, 3rd or 5th, Check Engine Light Illuminated, DTC P0776  
(Replace 3-5 Reverse Clutch Plate (Waved))

**Models:** 2008-2009 Buick Enclave  
2008-2009 Chevrolet Equinox, Malibu  
2009 Chevrolet Traverse  
2007-2009 GMC Acadia  
2007-2009 Pontiac G6  
2008-2009 Pontiac Torrent  
2007-2009 Saturn AURA, OUTLOOK  
2008-2009 Saturn VUE  
All Equipped with 6T70/75 6-Speed Automatic Transmission  
(RPOs MH2, MH4, MH6 or MY9)

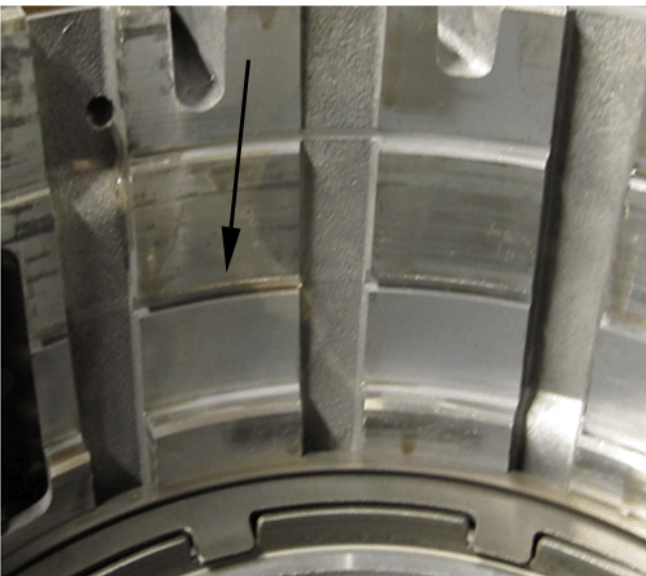
2753500

- The snap ring groove, which is well below the 3-5-R wave plate area, is unlikely to be damaged. It should still be checked to verify the snap ring is fully seated and to be securely retained.

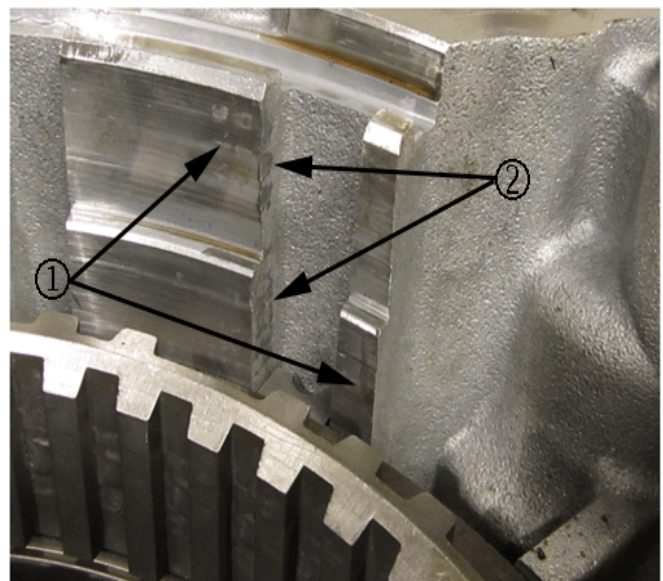
2753503

- Peening or wear of the face or edge of the case lugs that engage the steel clutch plates is normal and not cause for transmission replacement.

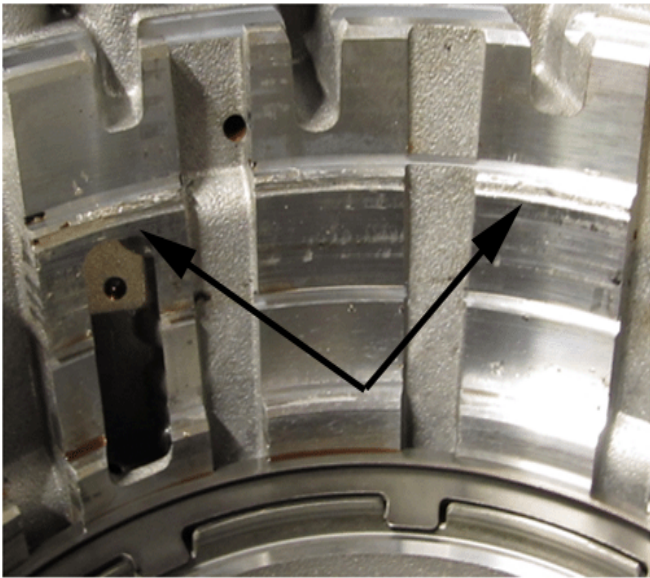
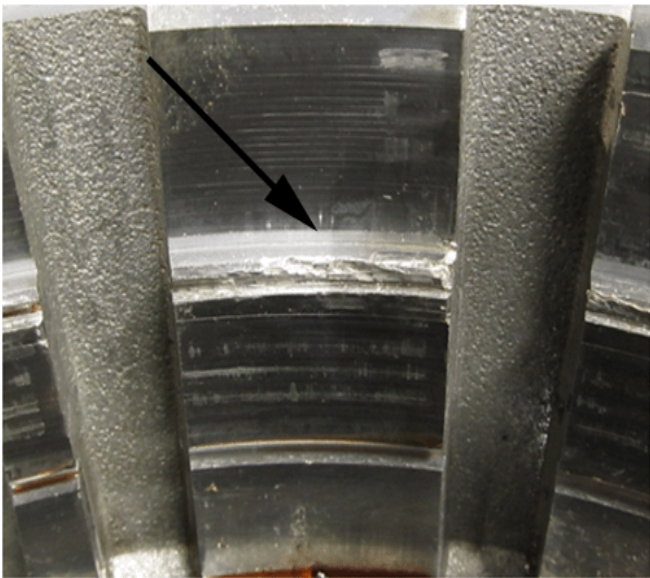
- Some degradation of the shelf for the 2-6 backing plate is acceptable as long as the plate can lie flat. A raised burr that prevents this can be removed using a de-burring tool, file or some other abrasive.
4. Remove the control valve body cover (1), control solenoid (w/body and TCM) valve assembly (15) and filter plate assembly (16).
  5. Inspect the filter plate assembly (16) for the presence of metallic debris on the screens.
    - If there is no debris on the screens, the pump fluid filter was effective and there is no debris in the pump or torque converter. Therefore the pump, torque converter and valve body do not need to be replaced. The transmission should be repaired.
    - If there is debris on the screens, the pump and torque converter should be inspected further. Refer to SI procedure Transmission Fluid Pump

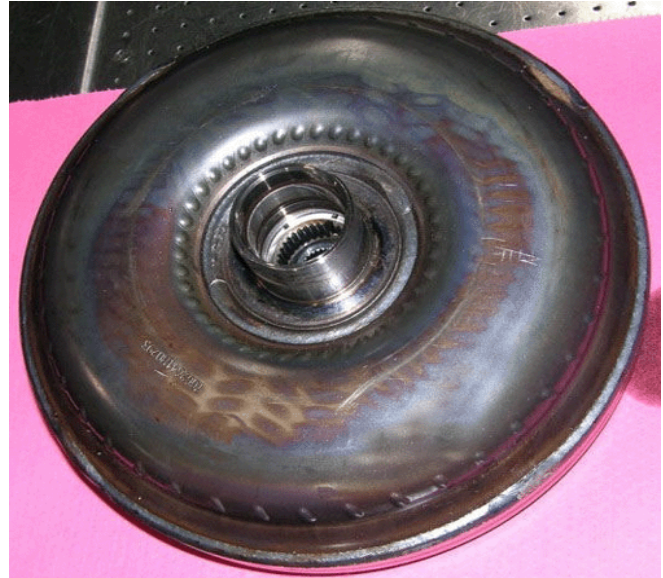
2739303

**Note:** The manufacturing process of the torque converter can cause the hub side to appear blue or darker in color while the lug side is a natural metal color. If the torque converter appearance is like this and no other reason is observed per the SI procedure for torque converter diagnosis, then the torque converter does not need to be replaced.

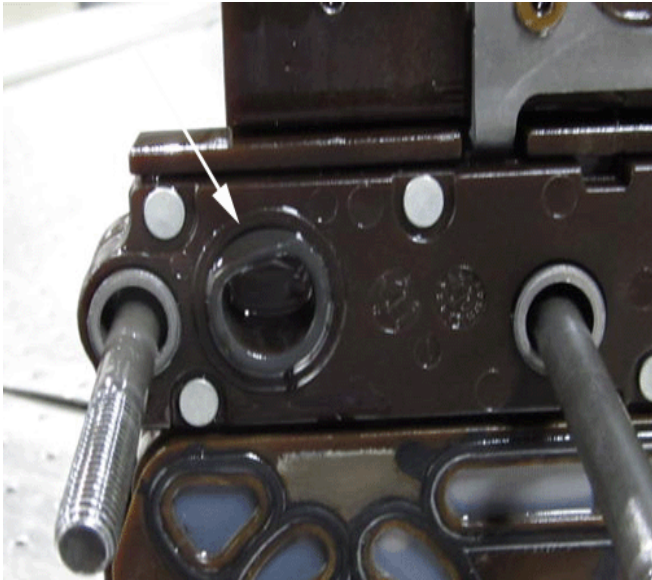
2850322

6. Inspect the control solenoid (w/body and TCM) valve assembly (TEHCM) (15) pressure switches. The O-ring seals may be deformed but if they are attached, as shown above, the TEHCM should not be replaced; it should be reused. Deformed seals do not affect switch performance.

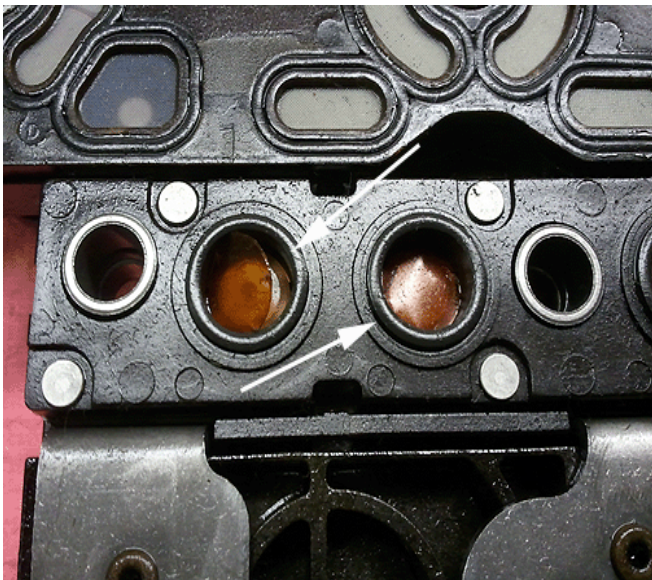
2630114

If any of the switch membranes are damaged, as shown above, the TEHCM must be replaced.

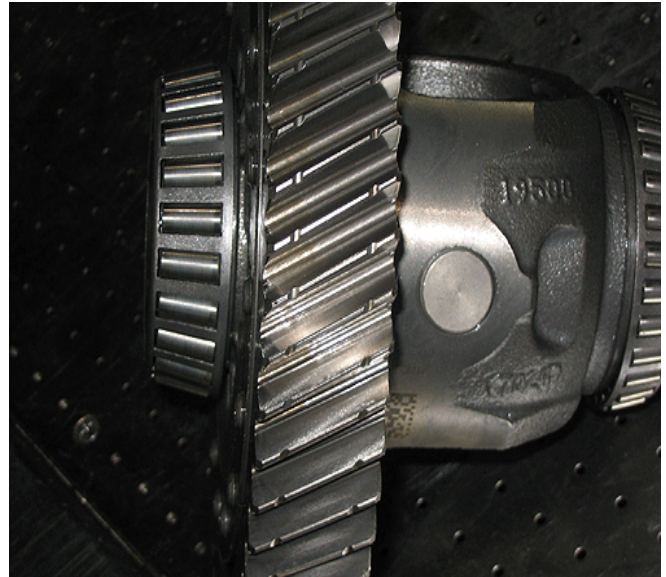
2584822

**Notice:** The front differential carrier assembly (31) teeth are marked with notches to identify gear ratio (see picture above). Do not confuse these marks with tooth damage. Do not replace the gear for this condition.

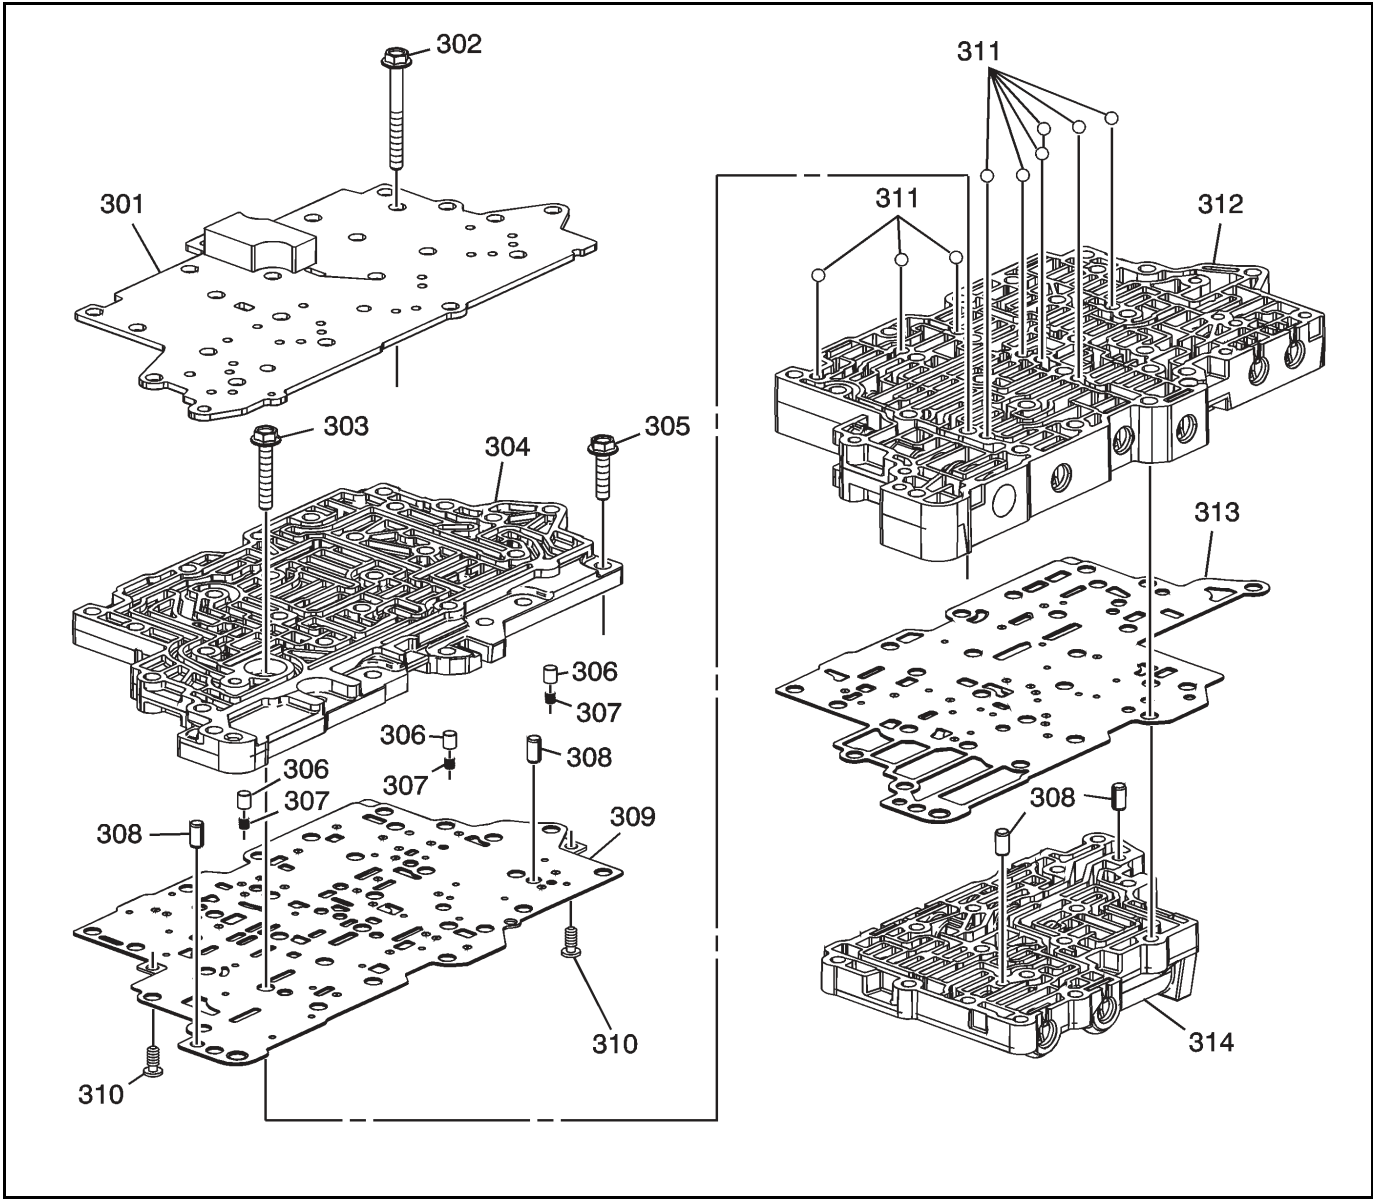
**Important:** 2007-2008 applications – when assembling these transmissions, inspect the control valve channel upper plate (301) to make sure that it contains the slot as indicated above. Plates installed that do not include this slot may result in DTCs.
