# Service Bulletin

Bulletin No.: 12-06-04-003

**Subject:** Diagnosis and Repair - Malfunction Indicator Lamp (MIL) Illuminated, Reduced Engine Power Message Displayed, DTC P2135 Set

**Models:** 2009-2011 Buick Lucerne  
2006-2008 Chevrolet Malibu  
2006-2011 Chevrolet Impala  
2006-2009 Pontiac G6  
Equipped with Engine RPO LGD, LZ4, LZ8 or LZE

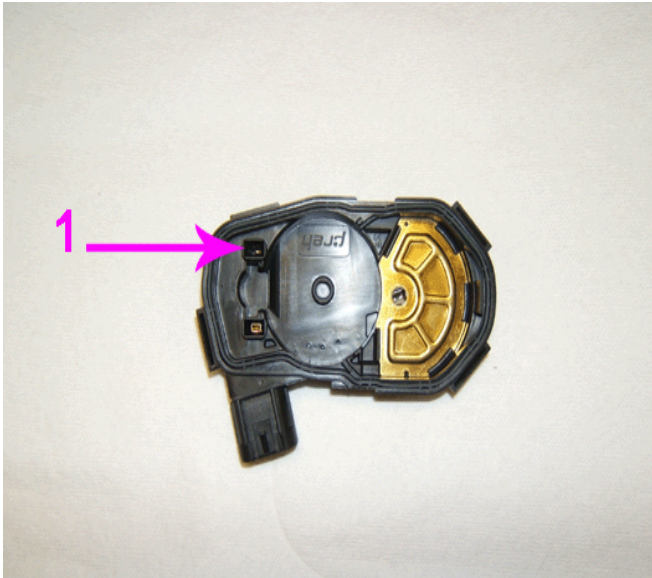
2909963

12. Inspect the TP sensor cover and verify that the TP sensor cover gasket **has remained** in the TP sensor cover as shown. Ensure that the gasket is accounted for and remains with the old TP sensor cover.

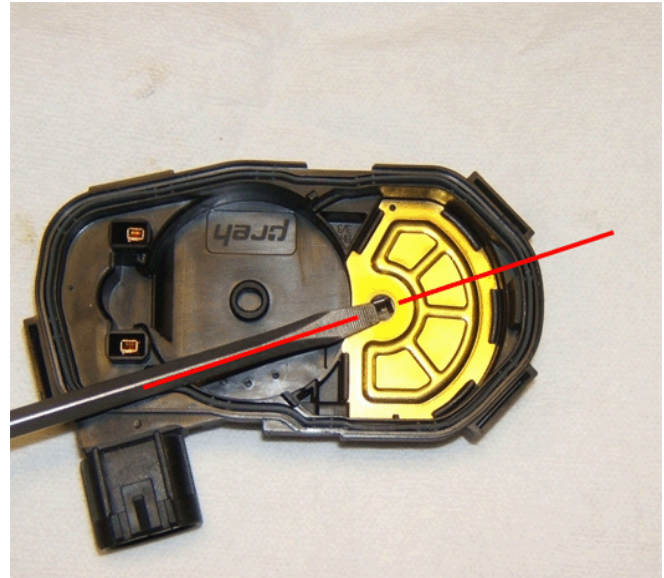
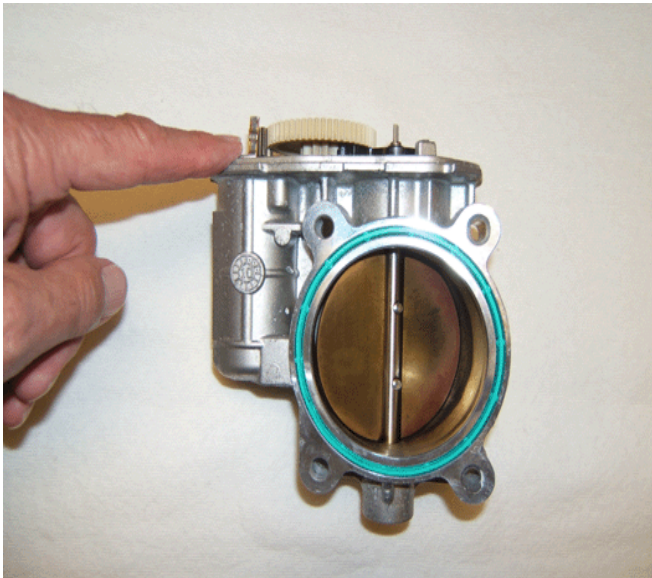
13. Observe the TP sensor cover for missing female throttle actuator motor terminals (1). Verify that the female throttle actuator motor terminals **have remained** in the TP sensor cover and **have not** been retained on the throttle actuator motor male terminals as shown. Discard the old TP sensor cover, gasket and terminals.

⇒ If one or both of the TP sensor cover female throttle actuator motor terminals have been retained on the throttle actuator motor male terminals, remove and discard those female terminals.
