# Service Bulletin

Bulletin No.: 12-06-04-003A

**Subject:** Malfunction Indicator Lamp (MIL) Illuminated, Reduced Engine Power Message Displayed, DTC P2135 Set

**Models:** 2009-2011 Buick Lucerne  
2006-2008 Chevrolet Malibu  
2006-2009 Chevrolet Uplander  
2006-2011 Chevrolet Impala  
2007-2009 Chevrolet Equinox  
2006-2009 Pontiac G6  
2006-2009 Pontiac Montana SV6  
2007-2009 Pontiac Torrent  
2006-2009 Saturn Vue  
2007 Saturn Relay  
2007-2009 Saturn Aura  
Equipped with Engine — RPO LGD, LZ4, LZ8, LZE, LZ9, LNJ or LZG

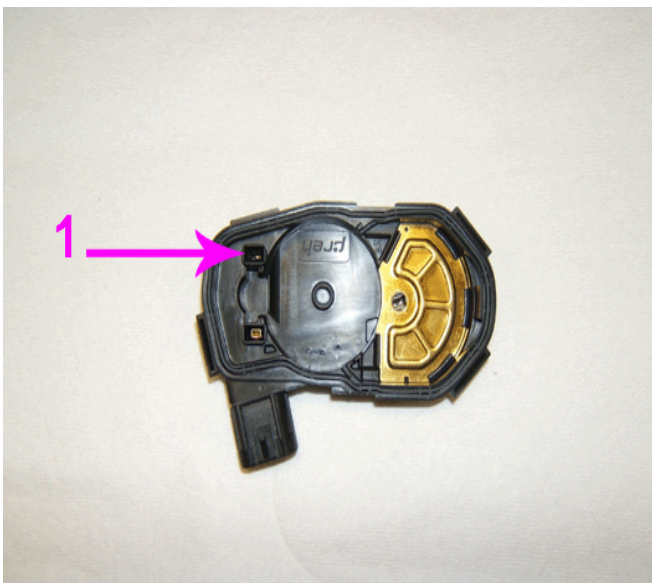
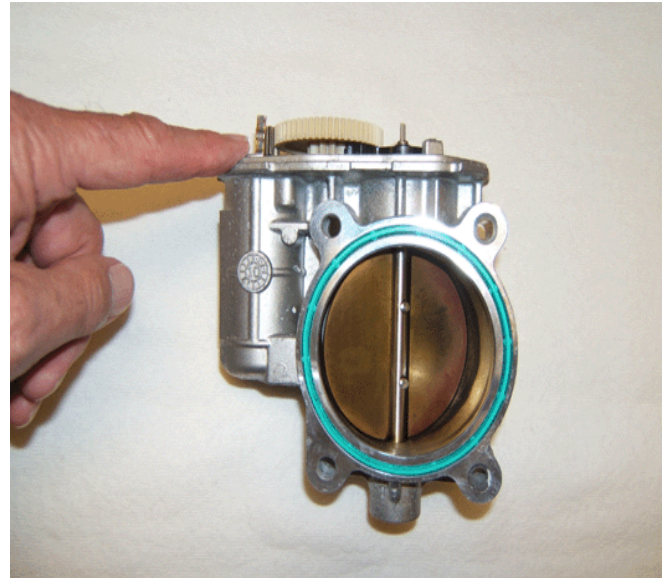
2909872

13. Observe the TP sensor cover for missing female throttle actuator motor terminals (1). Verify that the female throttle actuator motor terminals **have remained** in the TP sensor cover and **have not** been retained on the throttle actuator motor male terminals as shown. Discard the old TP sensor cover, gasket and terminals.

⇒ If one or both of the TP sensor cover female throttle actuator motor terminals have been retained on the throttle actuator motor male terminals, remove and discard those female terminals.

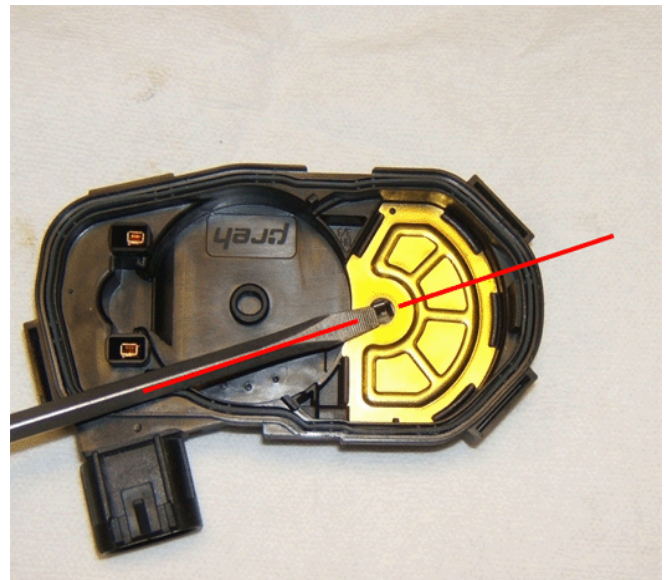
2911366

15. Place the TP sensor cover in the position as shown. Confirm the TP sensor drive slot orientation is aligned in the TP sensor cover as shown.

⇒ If the TP sensor drive slot orientation is not aligned as shown, use a small flathead screwdriver to gently rotate the TP sensor drive slot **clockwise** to the wide open throttle (WOT) position as shown.
