# Technical Service Bulletin

## 27 48V vehicle electrical system warning, DTC U046900 stored in the ECM

27 23 63 2058831/10 December 13, 2023. Supersedes Technical Service Bulletin Group 27 number 23-57 dated June 14, 2023 for reasons listed below.

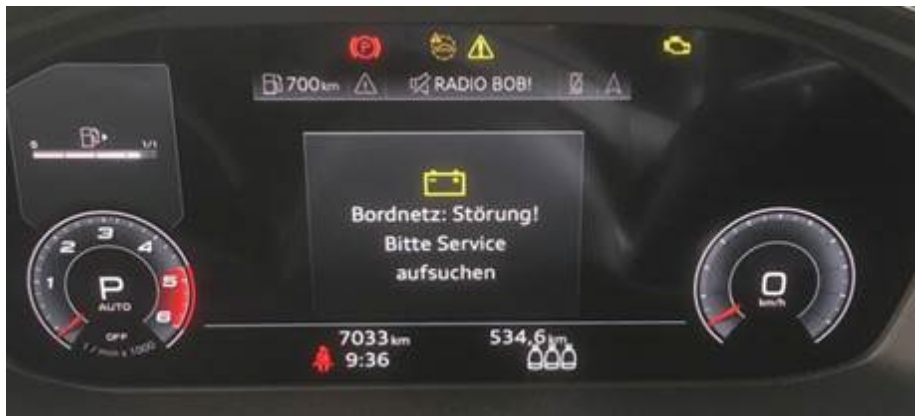
- The message “Electrical system: Malfunction. See owner’s manual” is displayed on the instrument cluster (figure 1).
- A yellow or red battery warning symbol is displayed on the instrument cluster.

**Figure 1.** Cluster Warning Message.

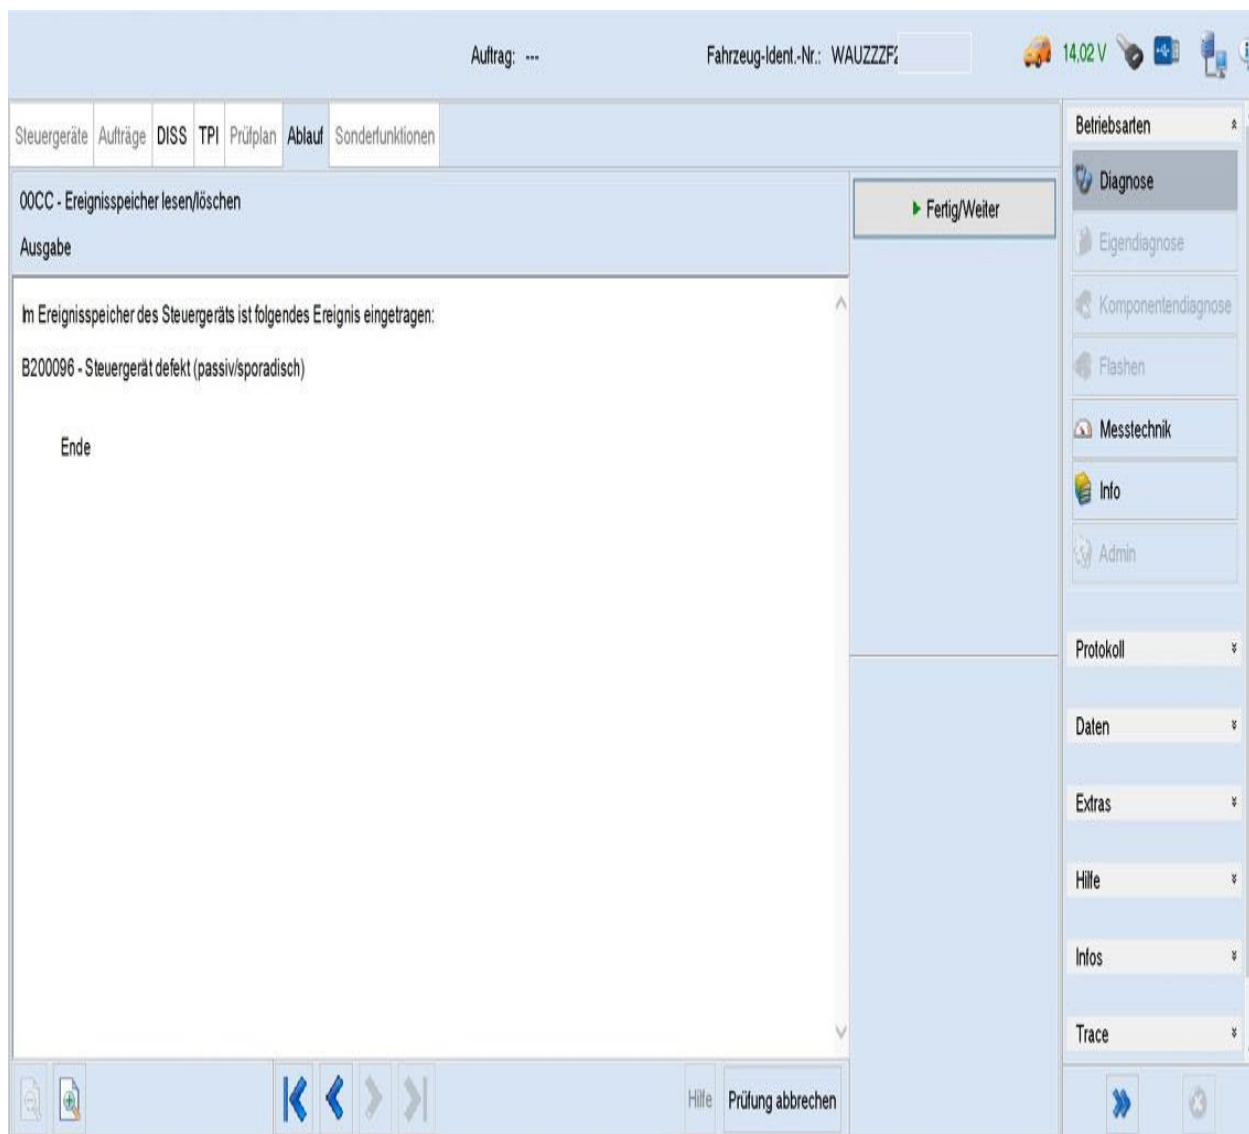
- **B200096** – Faulty control module (figure 2).

Figure 2. ODIS tester screen.

If the following event memory entry is shown in ODIS, replace the starter-alternator according to ETKA and reevaluate the concern:
