## STAR ONLINE PUBLICATION

**Case Number:** S1525000009 REV. C

**Symptom/Vehicle Issue:** Updated Diagnostic Trouble Code (DTC) P2BA9 – Insufficient Reductant Quality, “Service Diesel Exhaust Fluid (DEF) System” Message Reset Procedure.

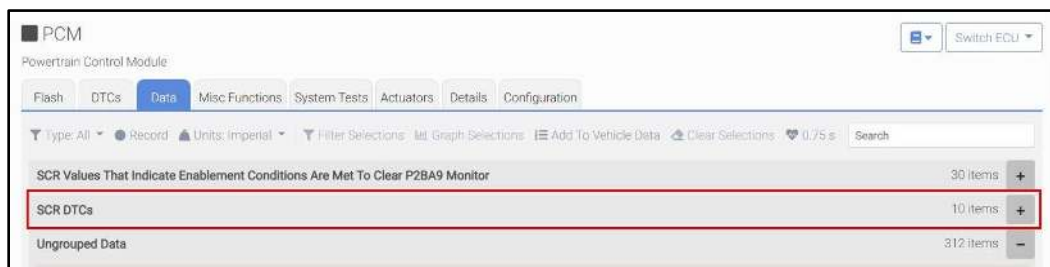
Figure 1.

3. Using wiTECH, navigate to the PCM DTCs tab and record the DTCs. If no DTCs are found, navigate to the PCM data tab. Expand the “SCR DTCs” group, and record the “SCR DTC” data parameters. Please see (Figures 1&2.). Is P2BA9 present in the PCM DTCs and/or 2BA9 present in the SCR DTC data parameters?
  - a. Yes>>> Proceed to (Step 4).
  - b. No>>> This document does not apply. Please follow normal published diagnostics for the other DTCs that are present.

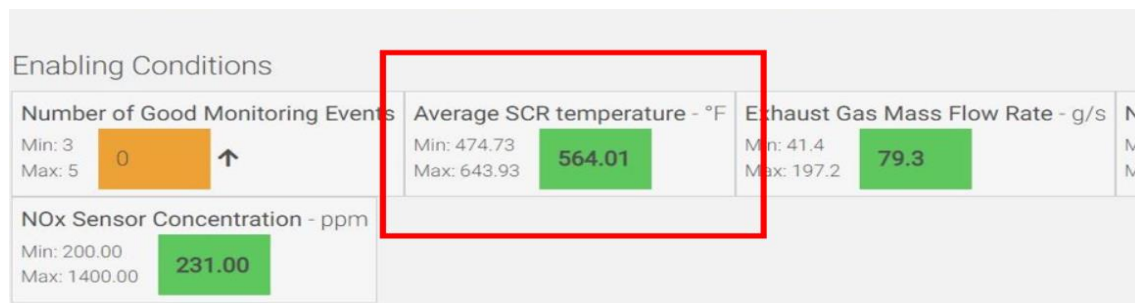
Figure 8.

**NOTE: While performing the above drive maneuver, the Average SCR temperature must remain between 475-644° F (246-340° C). Please see (Figure 8). Allowing the SCR temperature to fall outside these temps for too long will delay the monitor from running.**
