# Technical Service Bulletin

## 01 MIL on (P1545, P0121, P0123, P0221 or P0222 stored in ECM)

01 13 70 2018260/6 February 22, 2013. Supersedes Technical Service Bulletin Group 97 number 10-06 dated June 4, 2010 for reasons listed below.

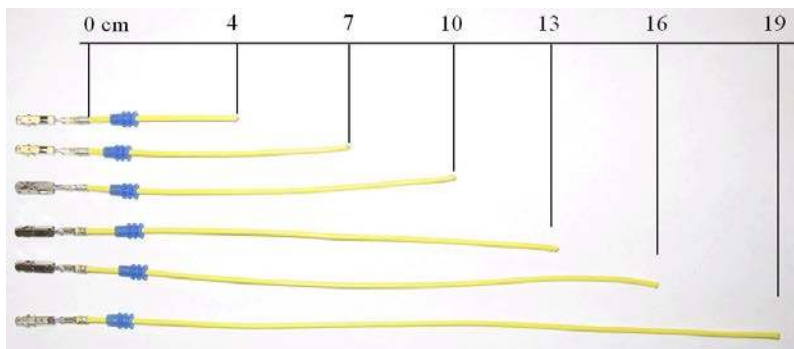
**Figure 1.** Correctly preassembled wires and seals.

3. Lengthen wires and preassemble seals as shown (Figure 1).

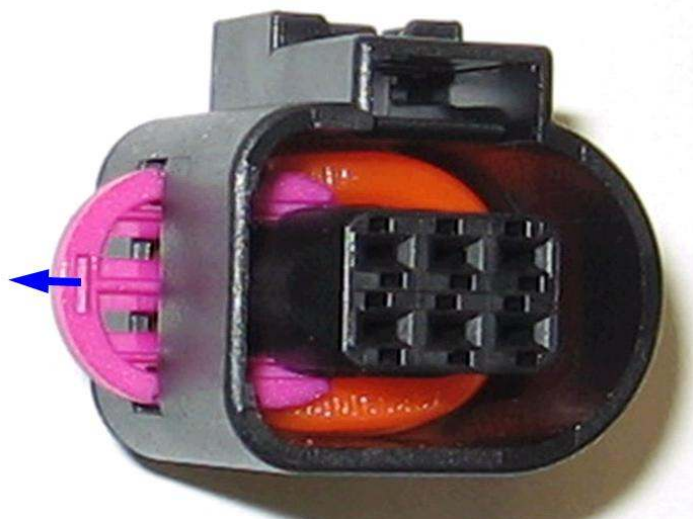
**Figure 2.** The slot to be used to remove the pink lock.

4. On the new housing, remove pink lock with small flathead screwdriver, using the slot on the pink lock (Figure 2).

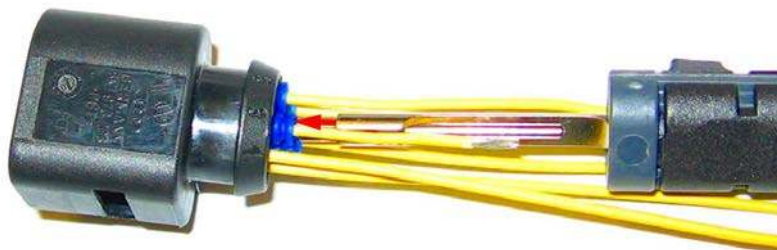
**Figure 3.** The single wire seal, slid as far as the stop.

5. Insert all terminals into housing until they audibly click.
6. Reinstall pink lock.
7. Using the appropriate assembly tool, slide the single wire seal up the repair wire until it contacts the housing. Continue to slide the single wire seal into the housing as far as the stop (Figure 3).
