## STAR ONLINE PUBLICATION

**Case Number:** S2408000005

**Symptom/Vehicle Issue:** Vehicle Staying Awake Intermittently Causing Battery Drain, BCM DTC B23D7-14 Gated Park Control-Circuit Short to Ground or Open

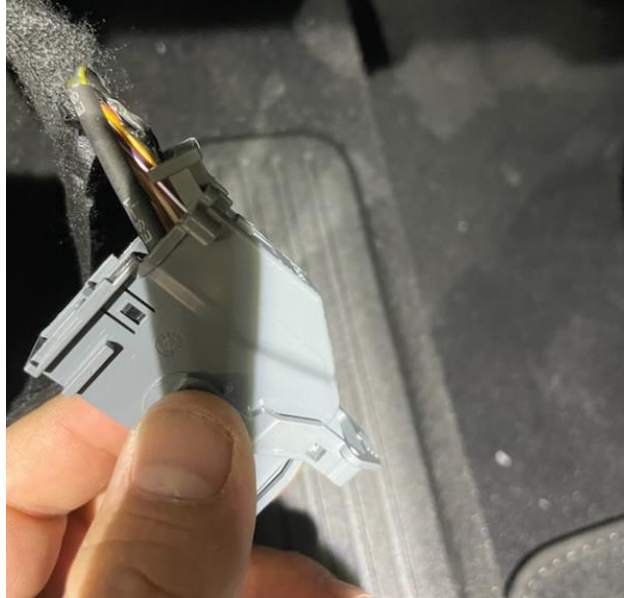
**BCM C4**

**Diagnosis:** Attempt to verify this is the cause by applying pressure to the BCM C4 connector to fully seat it into the BCM, the B23D7-14 status should change to Stored. Inspect BCM C4 connector (Gray 32pin) and determine if it is fully locked and secured.

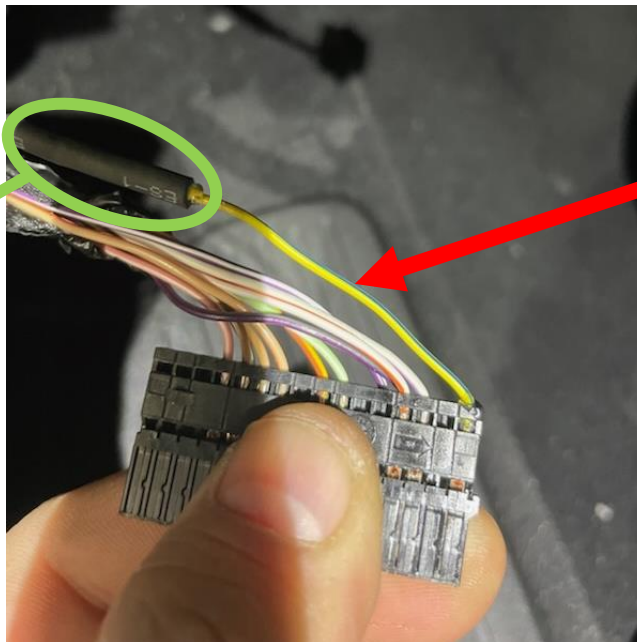
**C4 Gray Connector Housing Removed**

Remove the gray connector housing to gain access to the main connector body and terminals. Inspect T824 (YE/DB) in cavity 1 for excessive tension.

**Circuit T824  
(YE/DB)**

**Circuit Lengthening  
Repair**

**Repair:** If terminal or connector pull out is found, attempt to reroute the harness in a way to reduce tension on the T824 circuit. Alternatively, it may be necessary to lengthen the T824 circuit using wiring repair best practices.
