# Technical Service Bulletin

## 93 Update OBC software when replacing HV wiring harness for charging socket P31D200

93 24 47 2070110/4 March 22, 2024. Supersedes Technical Service Bulletin Group 93 number 23-17 dated July 26, 2023 for reasons listed below.

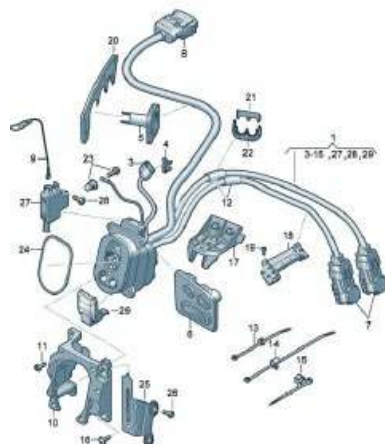
The High Voltage Wiring Harness for the charging socket UX4 or UX5 is replaced as part of any repair work (Figure 1).

**Figure 1.** High-voltage wiring harness for charging socket.

If the high-voltage wiring harness for the charging socket is replaced as listed in Table 1.2, an SVM code will need to be performed *and a replacement test plan performed*.
