# MIL ON With DTC P060694

| YEAR(S) | MODEL(S) | ADDITIONAL INFORMATION |
|---|---|---|
| 2021 - 2023 | Sienna HV | WMI(s): 5TD<br>Transmission(s): eCVT<br>Plant Code(s): S |

Some 2021 – 2023 model year Sienna Hybrid vehicles may exhibit a MIL ON condition with Diagnostic Trouble Code (DTC) P060694 (Hybrid/EV Powertrain Control Module Processor Unexpected Operation) present. The Hybrid Vehicle Control Computer logic has been modified to reduce the possibility of this DTC setting incorrectly. Follow the Repair Procedure in this bulletin to address this condition.

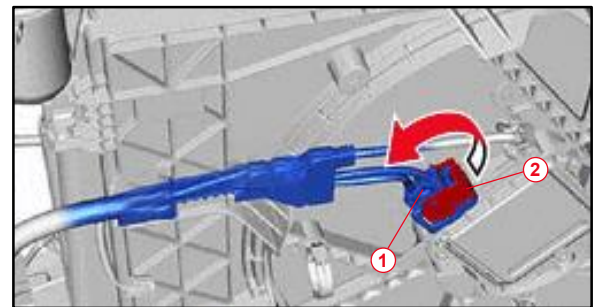
**Figure 1.**

| 1 | Cooling Fan Motor Connector |
| 2 | Lock |

- A. Disconnect the cooling fan motor connector.
- B. Rotate the lever while pushing the lock and disconnect the cooling fan motor connector.

After disconnecting the cooling fan motor connector, make sure that dirt, water, or other foreign matter does NOT contact the connecting parts of the cooling fan motor connector.

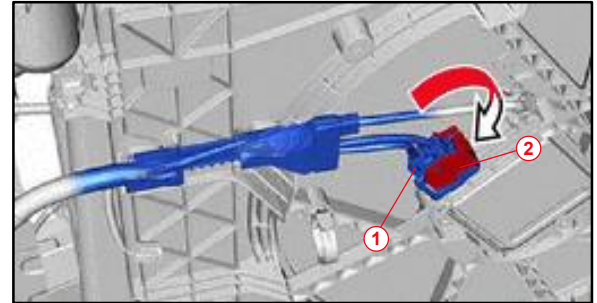
**Figure 2.**

| 1 | Cooling Fan Motor Connector |
| 2 | Lock |

4. Connect the cooling fans.
  - A. Connect the cooling fan motor connector.
  - B. Rotate the lever to lock it.

- When connecting the cooling fan motor connector, make sure that the connecting parts of the cooling fan motor connector are free of dirt, water, or other foreign matter.
- Be sure to securely connect the cooling fan motor connector.
