## PIP5932A Information on Malfunction Indicator Lamp (MIL) Illuminated with Any Combination of DTCs P0521, P06DD or P06DE Setting

| Brand: | Model: | Model Years: | VIN: | | Engine: | Transmissions: |
|---|---|---|---|---|---|---|
| Chevrolet | Trax | 2024 | All | All | 1.2L LIH | All |

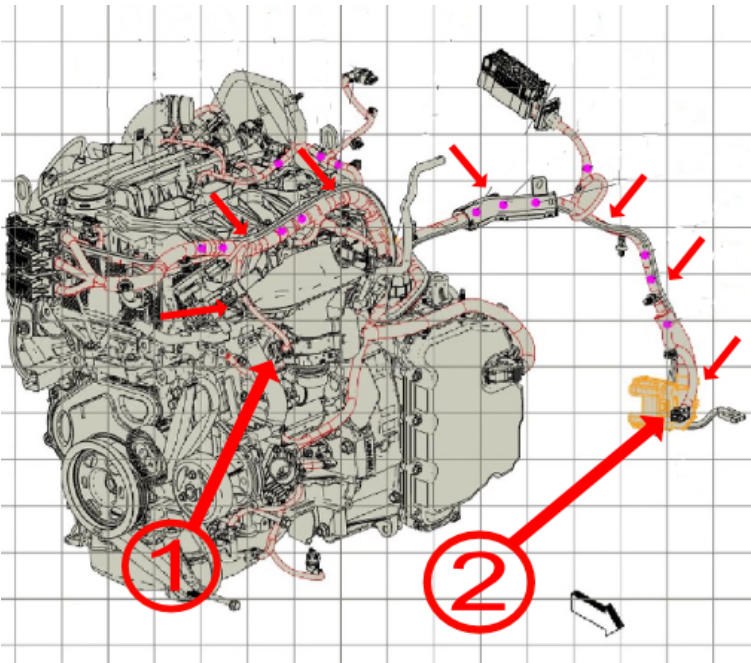
If the resistance is within range, tap and manipulate the engine wiring harness between the oil pressure sensor (1) and X125 (2) shown below, while monitoring for a change in the resistance reading.
