In the instrument cluster, the symbol for "12 V battery" and the message "Switch on vehicle" sporadically appears

| Topic number | LI54.10-P-076820 |
| Function group | 54.10 - Battery, power supply, voltage converter |
| Validity | MODEL 206 up to production 12/15/23<br>MODEL 254 up to production 12/15/23 |

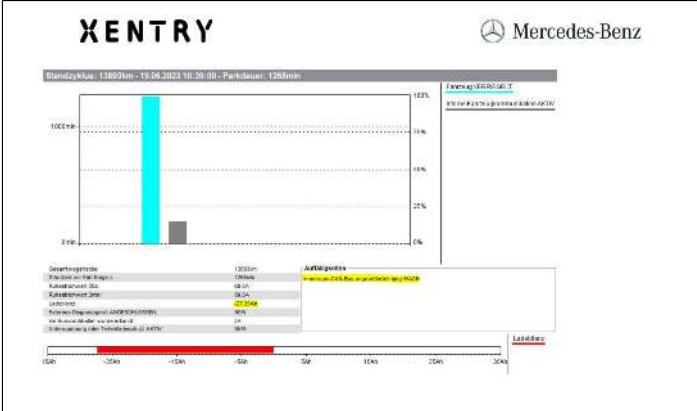
| Attachments | |
|---|---|
| <a href="#">Bild 1_de.JPG</a> | 12 V on-board electrical system data (German) |

In the subsequent analysis of the 12 V on-board electrical system data, the following parameters are noteworthy (see picture 1 in the attachment):

- Charge balance negative when stationary.
- Interior CAN bus is awake for an unusually long time while the vehicle was locked.
- 12 V battery SOC (state of charge) during subsequent engine start is 45% or less.

The door control unit (N69/x) may sporadically keep the interior CAN bus awake.

Update the software and coding on all 4 door control units (N69/1, N69/2, N69/3 and N69/4):

- To do so, a commissioning process must be started in the door control unit, left-hand front door (N69/1). The remaining door control units (N69/2, N69/3 and N69/4) are commissioned at the same time, in an automated process.(Path: Xentry Scope; Control Units View; TSG-XX (N69/1); Adaptations; Commissioning)
- The repair software has been available since 02.02.2024 and the new SCN coding since 04.06.2024.
- The measures are only 100% effective if the combination of "Repair software + new SCN coding" is used.
