| <b>Topic</b> | DTC P0B2500 logged within address 0021 (Battery Energy Control Module 2) - Dynamic ride system warning visible |
| <b>Transaction No.</b> | 2068946/8 |

DTC P0B2500 logged within address 0021 (Battery Energy Control Module 2) - Dynamic ride system warning visible

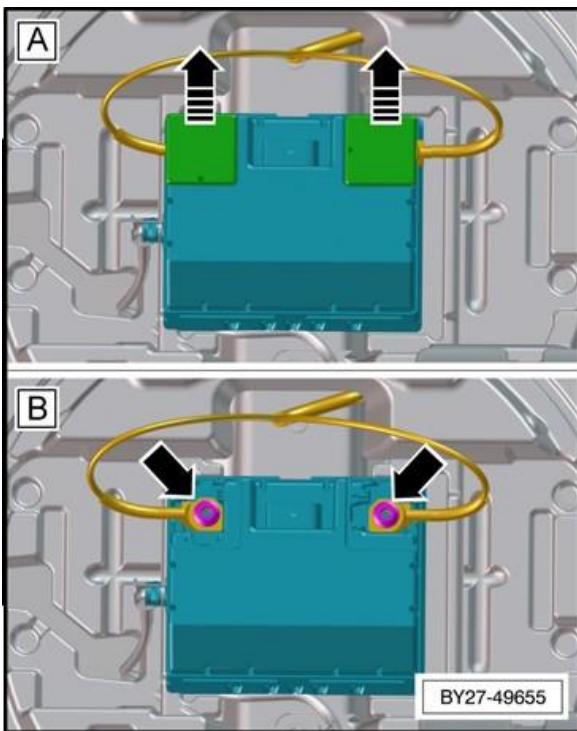
Figure 1

Possible internal fault with the super capacitor

- Referring to Rep.Gr 27 - Deactivate the 48 volt system - Refer to 48 volt system - To activate and deactivate
- Referring to Rep.Gr 27 - Check the security of the super capacitor positive and negative terminals (Figure 1) as follows:
  - Remove the caps (A) from the terminals
  - Check the security of the positive and negative terminals (B) are as described within Rep.Gr 27
  - In the event that one or both terminals were not tightened to the correct torque as Rep.Gr 27, the operative must tighten the terminal(s) to the correct torque as detailed within Rep.Gr 27 - Super capacitor

**In the event one or both terminals required tightening to the correct torque (found to be not initially secure) the operative must feedback the findings via DISS**
