# Technical Service Bulletin

## 93 A7/Q5 PHEV Gearbox: drive system fault displayed in instrument cluster (P0A4000)

93 24 01 2074662/1 July 31, 2024.

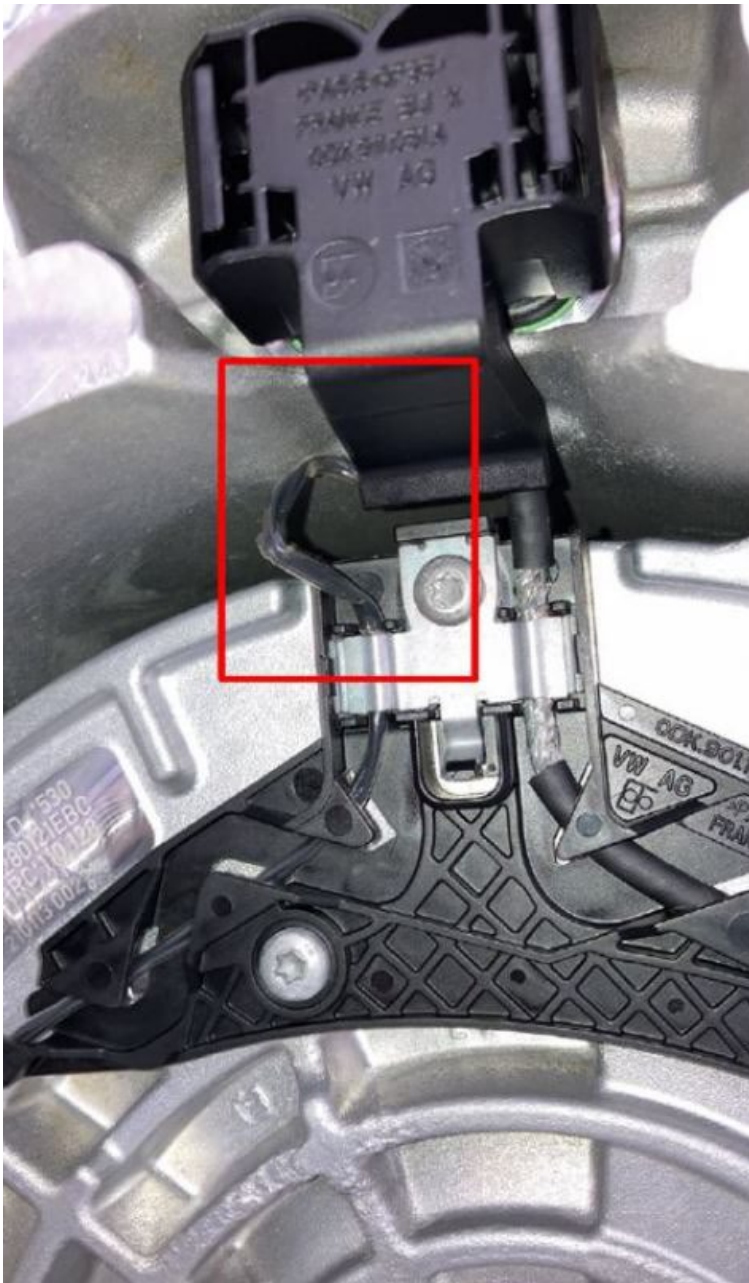
**Figure 1.** Wire not fitted correctly

- **If no other causes can be detected, replace drive motor rotor position sender 1 G713 (rotor position sensor) according to Workshop Manual.**

**Please work with great care when installing the rotor position sensor so that the sensitive wires on the gearbox housing are positioned correctly.**

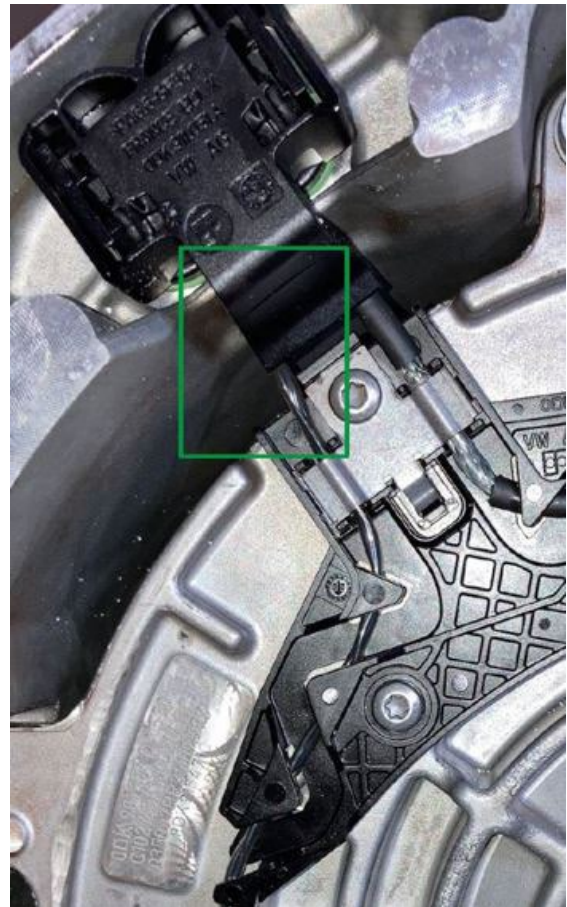
**Figure 2.** Installation according to Workshop Manual
