# Technical Service Bulletin

## 48 Vehicle cannot be started (DTC P160A00); Steering column can be pushed in too far

48 24 71 2073237/2 September 10, 2024. Supersedes Technical Service Bulletin Group 48 number 24-63 dated March 5, 2024 for reasons listed below.

| Model(s) | Year | VIN Range | Vehicle-Specific Equipment |
|---|---|---|---|
| Q3 | 2019 – 2025 | All | Not Applicable |

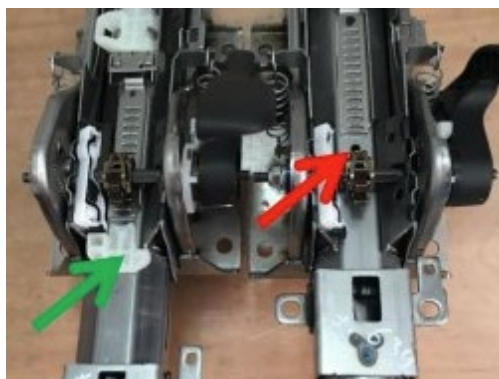
- The customer statement can be reproduced.
- Regarding to 1) The DTC **P160A00 Control Module Faulty** has been logged in the electronic steering column lock (diagnostic address 002B).
- Regarding to 2) The longitudinal stop on the steering column is damaged/missing (Figure 1).

**Figure 1.** Steering column on left is OK (the longitudinal stop is installed); steering column on right is not OK (the longitudinal stop is missing).

- When adjusting the steering column, excessive force was applied to the longitudinal stop, damaging it.
- It is not possible to modify/optimize the longitudinal stop as it must comply with the required safety standards.
- The procedure for checking the steering column is described in the Workshop annual.
- If the longitudinal stop is missing, it may no longer be possible to engage or release the electronic steering column lock under unfavorable circumstances.
- If the electronic steering column lock does not reach its end stops, it no longer approves the terminal release, and the ignition cannot be switched on.

**Please explain to the customer that excessive force should not be applied when adjusting the steering column.**
