**TECHNICAL INSTRUCTIONS**  
**FOR**  
**SPECIAL SERVICE CAMPAIGN 24TC05**  
**MALFUNCTION INDICATOR LAMP (MIL) IS ON WITH DTC P05CE00**  
**SOFTWARE UPDATE**

**CERTAIN 2023 & 2024 HIGHLANDER VEHICLES**  
**CERTAIN 2024 GRAND HIGHLANDER VEHICLES**

**Updated 10.10.2024 – Added Note to Confirm Calibration ID**

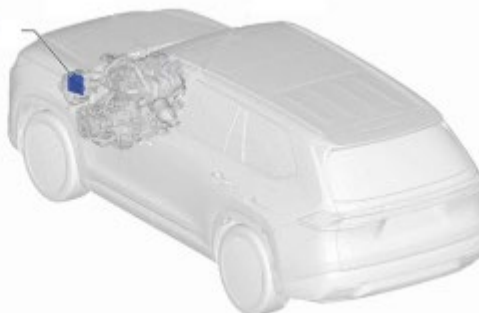
ENGINE CONTROL COMPUTER

The Engine Control Computer software has a programming error which can cause the exhaust variable valve timing (VVT) locking pin to temporarily get stuck. When this happens, an engine malfunction indicator lamp (MIL) can appear on the dashboard as well as diagnostic trouble code (DTC), P05CE00 to be set.
