**TECHNICAL INSTRUCTIONS**  
**FOR**  
**SPECIAL SERVICE CAMPAIGN 24LC03**  
**MALFUNCTION INDICATOR LAMP (MIL) IS ON WITH DTC P05CE00**  
**SOFTWARE UPDATE**

**CERTAIN 2023-2024 NX 350 VEHICLES**  
**CERTAIN 2023-2024 RX350 VEHICLES**  
**CERTAIN 2024 TX 350 VEHICLES**

**Updated 10.10.2024 – Add Note to Confirm Calibration ID**

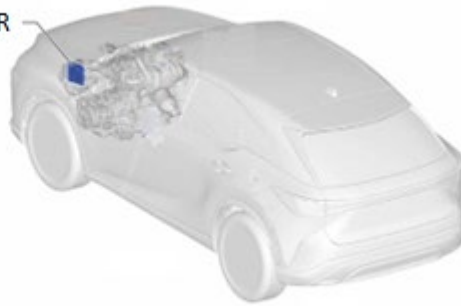
ENGINE CONTROL COMPUTER

The Engine Control Computer software has a programming error which can cause the exhaust variable valve timing (VVT) locking pin to temporarily get stuck. When this happens, an engine malfunction indicator lamp (MIL) can appear on the dashboard as well as diagnostic trouble code (DTC), P05CE00 to be set
