## Check engine light active - Fault P3007F1, P3007F2, P300CA8, or P300CA9 present in CDI control unit

| Topic number | LI14.30-N-075882 |
| Function group | 14.30 - Secondary air injection |
| Validity | Model 907 with engine 654 |

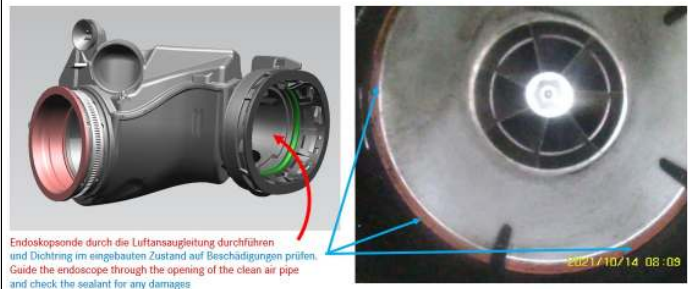
- If there is a leakage upstream of the exhaust gas turbocharger. Please refer to the file attached as "Dichtring\_Sealant.jpg.
- There is a defective hot film mass air flow sensor or a hot film mass air flow sensor that is affected by incorrect airflow (this can be due to a clogged or deformed air filter). Refer to the attached file "Luftfilter\_air\_filter."
- If the intake manifold (charge air distribution line) or the charge air cooler is carbonized. For more information, see the file attached as "Saugrohr\_intake\_manifold.jpg."
- If the timing is misadjusted.
- If there is carbonization or incomplete closure of the high-pressure or low-pressure exhaust gas recirculation valve, particularly in the housing intermediate flange connected to the high-pressure exhaust gas recirculation valve (which is linked to the exhaust back pressure sensor).

| Attachments | |
|---|---|
| <a href="#">Dichtring_Sealant.jpg</a><br> <p>Endoskopoende durch die Luftansaugleitung durchführen und Dichtring im eingebauten Zustand auf Beschädigungen prüfen.<br/>Guide the endoscope through the opening of the clean air pipe and check the sealant for any damages</p> | |

4) Inspect the sealing ring between the exhaust gas turbocharger and the clean airline (see the annex "Dichtring\_Sealant\_nok") for damage while in the installed position, using an endoscope. If any issues are detected, perform the necessary repairs.

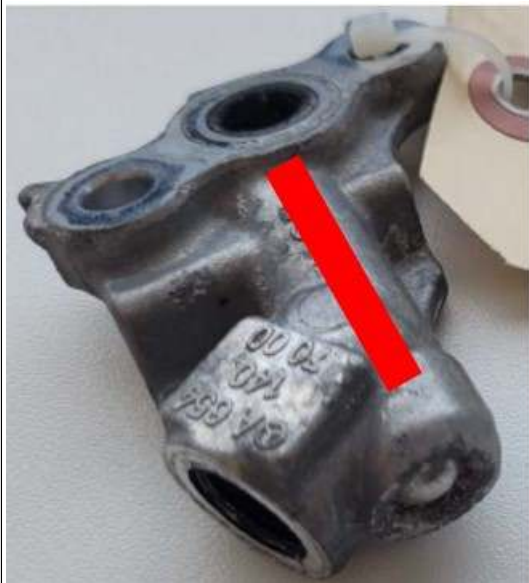
| Attachments | |
|---|---|
| <a href="#">Gehaeusezwischenflansch_Intermedidate_Flange.jpg</a><br> | |

- There is a leakage upstream of the exhaust gas turbocharger.
- The housing intermediate flange located at the high-pressure exhaust gas recirculation valve (where the exhaust back pressure sensor connects) is carbonized or clogged. Please refer to the attached file "Gehaeusezwischenflansch\_intermediate\_flange.jpg."

- Carbonization of the intermediate housing flange at the high-pressure EGR valve, specifically at the connection for the exhaust back pressure sensor.

2) Inspect the housing intermediate flange on the high-pressure exhaust gas recirculation (EGR) valve, specifically at the connection for the exhaust back pressure sensor. Use a flashlight to check for any inconsistencies or carbon buildup.

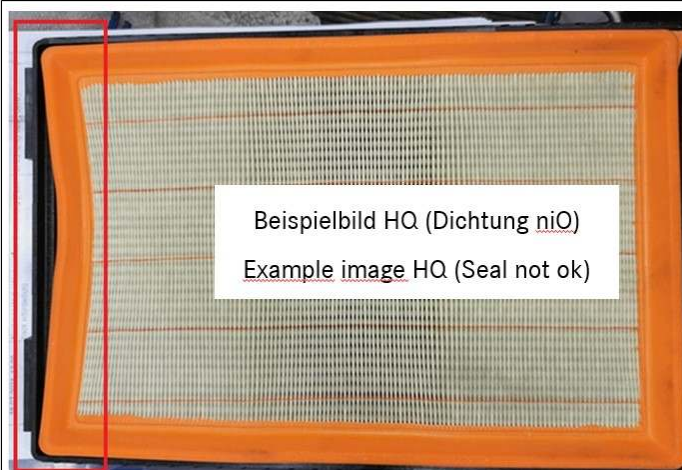
- The engine timing is misadjusted.
- There is a defective hot film mass air flow sensor or a hot film mass air flow sensor that is affected by incorrect airflow (this can be due to a clogged or deformed air filter). Refer to the attached file "Luftfilter\_air\_filter."
- There is carbonization or incomplete sealing of the high-pressure or low-pressure exhaust gas recirculation valves.

- There is a leakage downstream of the exhaust gas turbocharger.
- The charge air distribution line (intake manifold) is severely carbonized. See file in annex "Saugrohr\_intake\_manifold.jpg".
- There is a defective hot film mass air flow sensor or a hot film mass air flow sensor that is affected by incorrect airflow (this can be due to a clogged or deformed air filter). Refer to the attached file "Luftfilter\_air\_filter."

6) Conduct a visual inspection of the air filter for dirt or deformation.

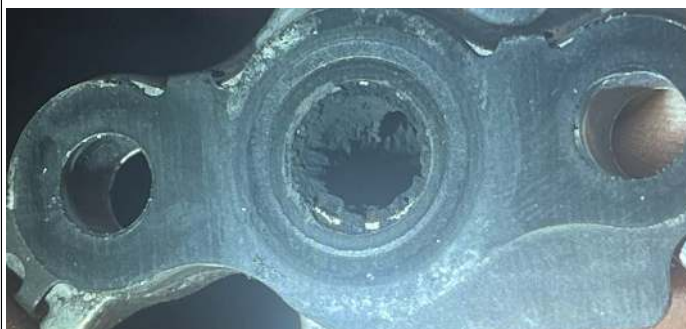
[verstopfter\\_Gehaeusezwischenflansch\\_clogged\\_Intermedate\\_Flange.jpg](#)

**\*\*Note:\*\*** This is only relevant if the correction value in load range 1 is less than -8%. See the attached file "verstopfter\_Gehaeusezwischenflansch\_clogged\_Intermediate\_Flange.jpg."

**\*\*Note:\*\*** This step is only necessary if the correction value for air intake in load range 1 is less than -8%.

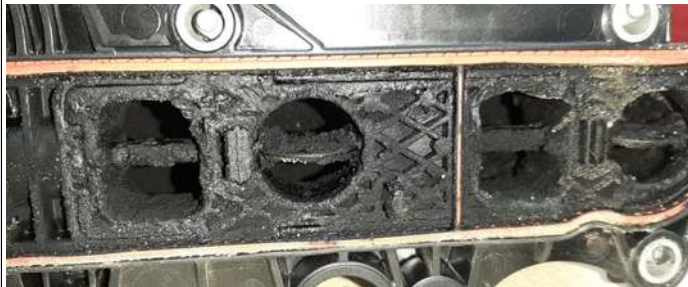
[Saugrohr\\_Intake\\_manifold.jpg](#)

- There is a leak located downstream of the exhaust gas turbocharger.
- The charge air distribution line (intake manifold) is heavily carbonized. Please refer to the attached file "Saugrohr\_intake\_manifold.jpg" for reference.
- If there is carbonization or incomplete closure of the high-pressure exhaust gas recirculation valve, particularly in the housing intermediate flange connected to the high-pressure exhaust gas recirculation valve (which is linked to the exhaust back pressure sensor).

- Check the charge air distribution line for carbon buildup.

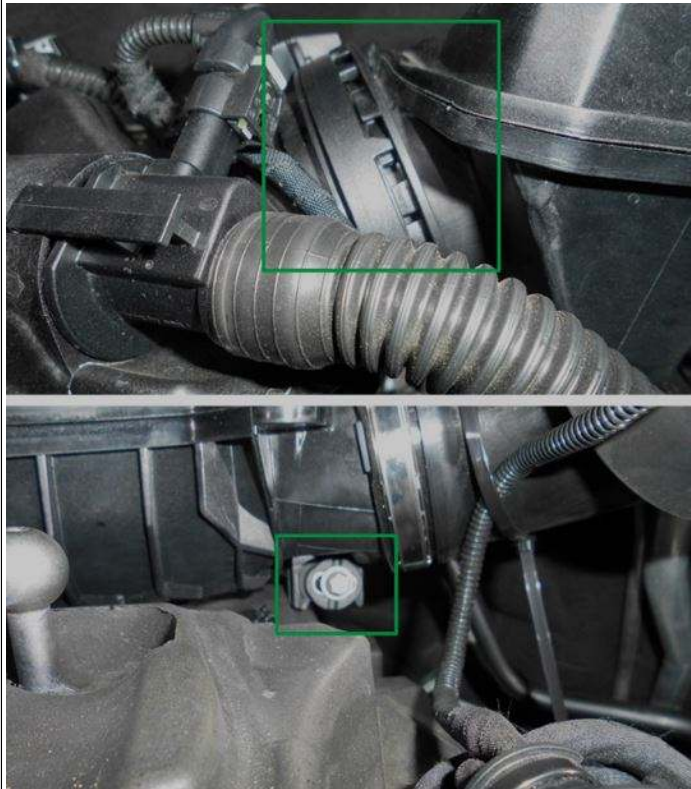
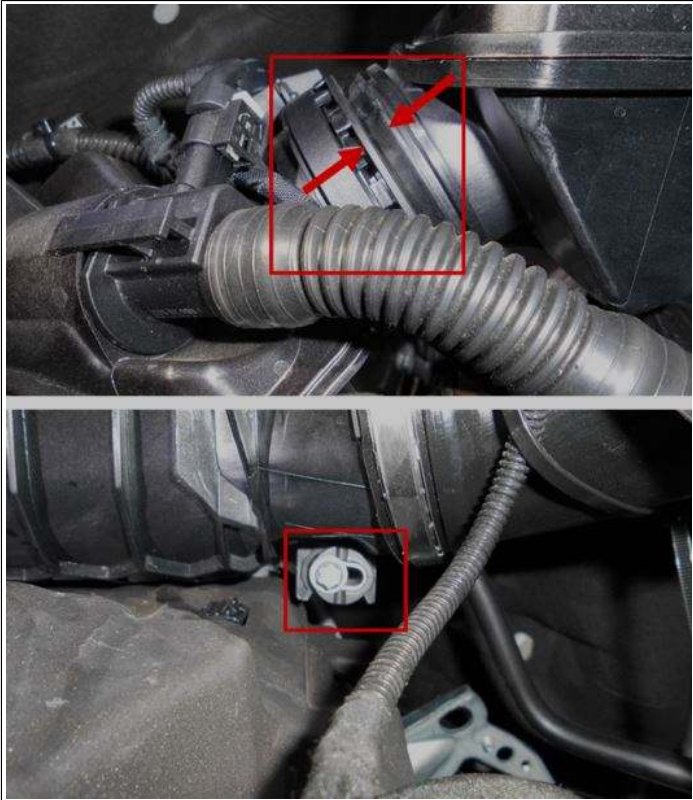
**\*\*Note:\*\*** See WIS documents AR09.10-D-8130TSM and AR09.40-D-0500TSM for further details. Examples of proper and improper installations can be found in pictures 3 and 4.
