## STAR ONLINE PUBLICATION

**Case Number:** S2219000005 Rev. C

**Symptom/Vehicle Issue:** Check Engine Lamp On. Warning Messages In The Cluster. U0131 Lost Communication With Power Steering Control Module Set.

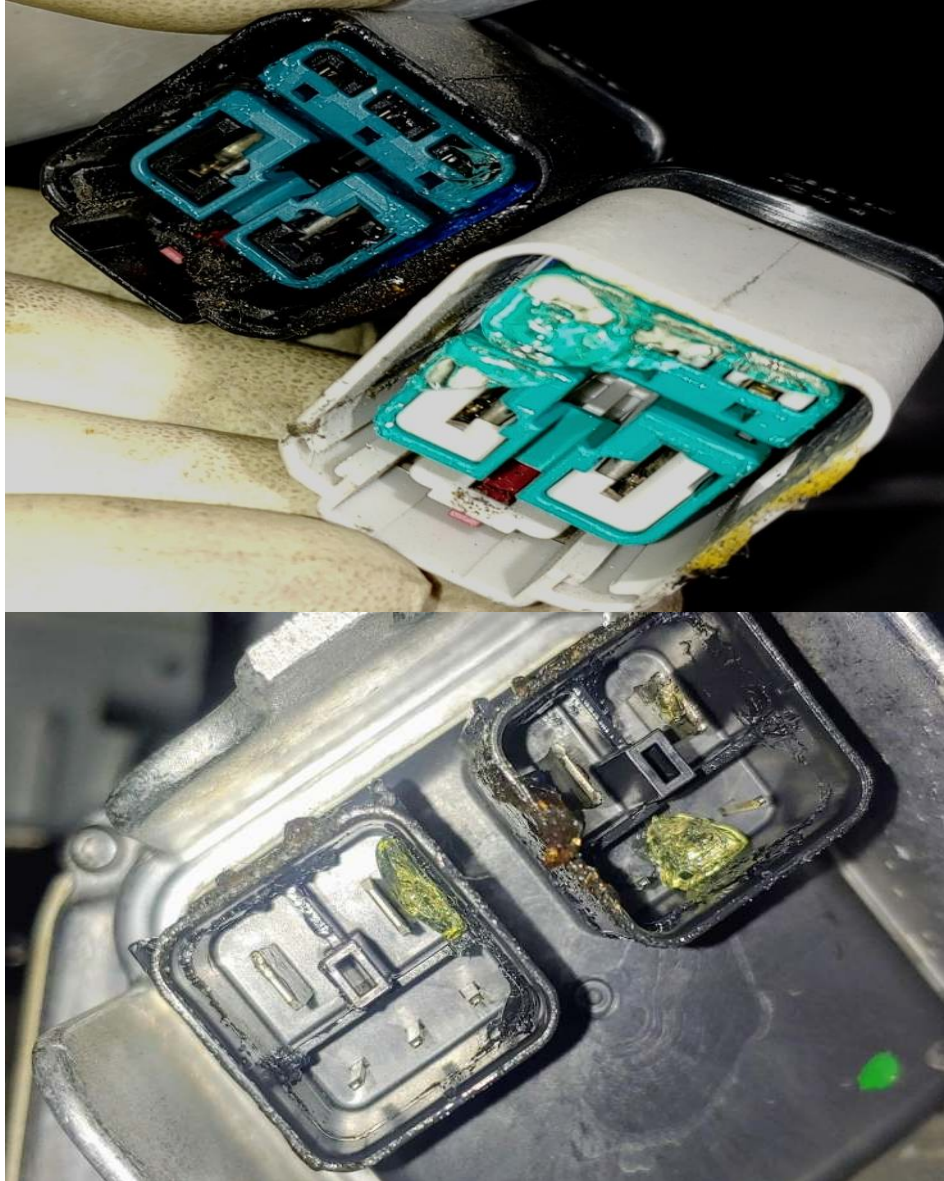
Examples of factory applied dielectric grease. **Do not add to or remove the grease.**

**Discussion:** First, review any applicable service bulletins and information that may apply to a customer complaint. If DTC U0131 Lost Communication with Power Steering Control Module is set, do not start with replacing the EPS. Verify the EPS connectors are fully snapped in by pushing on the connectors. Comments from field technicians show concerns with the amount of grease found in the EPS connectors. The amount shown in the images is applied at assembly and is correct. Dielectric grease is used in this location due the EPS location and contact with moisture and IS NOT the cause of U0131 DTC. Do not add to or remove the factory applied grease. Inspect the pins for push out and damage such as being bent. Inspect the EPS ground locations. Clean connection points and tighten grounding cables.
