## Technical Service Bulletin (TSB)

### Flash: Battery Pack Control Module (BPCM) Updates

| REFERENCE: | TSB: 08-022-25 REV. A<br>GROUP: 08 - Electrical | Date: | February 15, 2025 | REVISION: | 08-022-25 |
| VEHICLES AFFECTED: | 2024 (LB) Dodge Charger<br>This bulletin applies to vehicles equipped with 400V G2500 FR/RR Elec Drive Motors (Sales Code ELD). | | | MARKET APPLICABILITY:<br><input checked="" type="checkbox"/> NA<br><input checked="" type="checkbox"/> SA<br><input checked="" type="checkbox"/> EE<br><input checked="" type="checkbox"/> MEA<br><input checked="" type="checkbox"/> IAP<br><input checked="" type="checkbox"/> CH | |

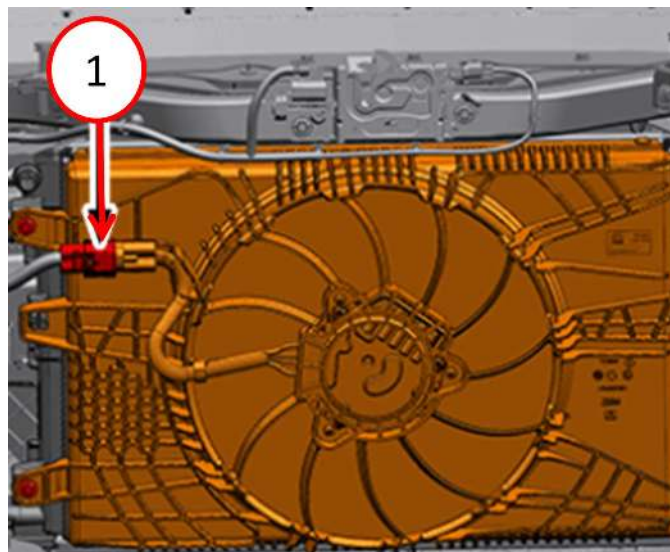
**Fig. 1**  
Cooling Fan Assembly

1 - Wire Harness To Disconnect/Connect

4. Disconnect the cooling fan wire harness connector [Fig 1\\*\\*](#).

21. \*\*Connect the cooling fan wire harness connector [Fig 1](#).
