**Technical Service Bulletin (TSB)**  
**Flash: Electronic Vehicle Control Unit (EVCU) Updates**

| REFERENCE: | TSB: 08-026-25 REV. A<br>GROUP: 08 - Electrical | Date: | February 15, 2025 | REVISION: | 08-026-25 |
| VEHICLES AFFECTED: | 2024 (LB) Dodge Charger<br>This bulletin applies to vehicles equipped with 400V G2500 FR/RR Elec Drive Motors (Sales Code ELD). | | | MARKET APPLICABILITY:<br><div><input type="checkbox"/> NA<input type="checkbox"/> MEA<br/><input type="checkbox"/> SA<input type="checkbox"/> IAP<br/><input type="checkbox"/> EE<input type="checkbox"/> CH</div> | |

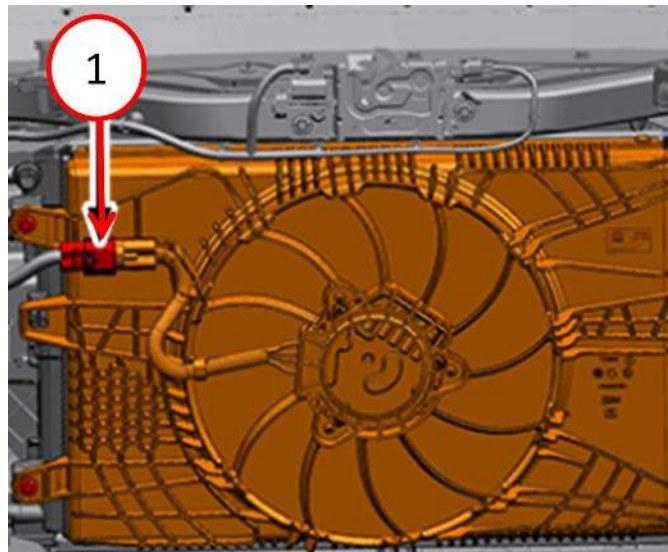
**Fig. 1**  
Cooling Fan Assembly

1 - Wire Harness To Disconnect/Connect

4. Disconnect the cooling fan wire harness connector [Fig. 1\\*\\*](#).

21. \*\*Connect the cooling fan wire harness connector [Fig. 1](#).
22. Install the front storage bin. Refer to the detailed service procedures available in DealerCONNECT/ ServiceLibrary under: Service Info> 23 - Body / Exterior / Bin, Storage / Installation.\*\*
