## Technical Service Bulletin (TSB)

### Flash: Powertrain Control Module (PCM) Updates

| REFERENCE: | TSB: 18-011-25<br>GROUP: 18 - Vehicle Performance | Date: | March 8, 2025 | REVISION: | – |
| VEHICLES AFFECTED: | 2024 (JL) Jeep Wrangler<br>This bulletin applies to vehicles built on and before January 30, 2024 (MDH 0130XX) equipped with a 2.0L I4 DOHC DI Turbo Engine W/ESS (Sales Code EC1). | | | MARKET APPLICABILITY:<br><div><input checked="" type="checkbox"/> NA<input type="checkbox"/> MEA<br/><input type="checkbox"/> SA<input type="checkbox"/> IAP<br/><input type="checkbox"/> EE<input type="checkbox"/> CH</div> | |

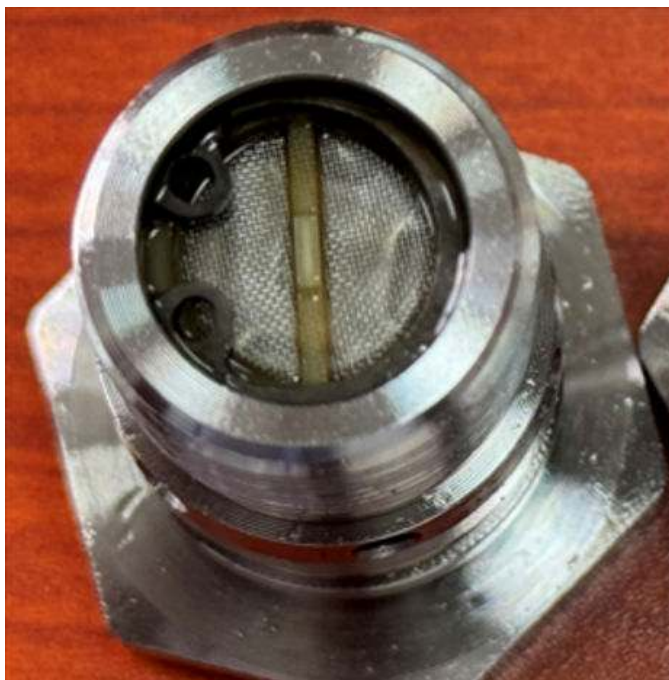
**Fig. 1**  
OCV Filter OK

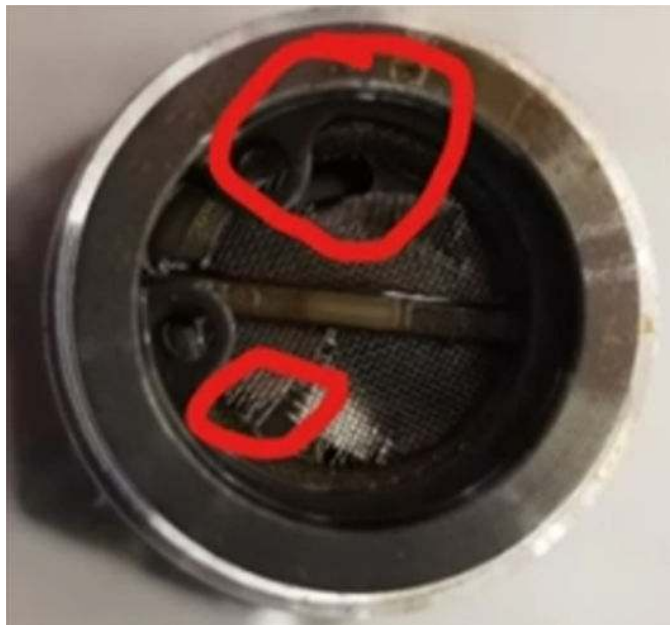
**Fig. 2**  
OCV Filter Torn

5. Are the OCV filter screen(s) torn?
  - YES>>> Replace the OCV(s) and change the engine oil and filter. Refer to the detailed service procedures listed in DealerCONNECT>Service Library>Service Info>under: 09 - Engine, 2.0L / Lubrication / Standard Procedure Engine oil and filter change. Use LOPs (09-05-37-91) and (26-99-00-10). Proceed to [Step 11](#).

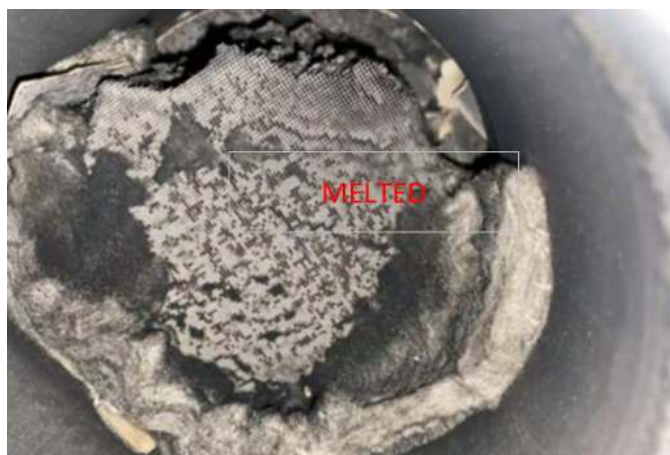
- NO>>> Follow diagnostic procedures referring to DealerCONNECT>Service Library> Service info>28 - DTC-Based Diagnostics / Module, Powertrain Control (PCM), 2.0L>P0420-Catalyst System Efficiency Below Threshold Bank 1. Remove the Upstream Oxygen Sensor and using a borescope, is the catalytic converter internally melted/cracked or brain pattern [Fig. 3](#) and [Fig. 4](#)?

**Fig. 3**  
Melted Catalyst

10. ● YES>>> Replace the catalytic converter. Refer to the detailed service procedures listed in DealerCONNECT>Service Library>Service Info>under: 11 - Exhaust System / Converter, Catalytic / Removal and Installation. Use LOP (11-50-01-91). Proceed to [Step 11](#).
- NO>>> Use Inspect LOP (11-50-01-90). Proceed to [Step 11](#).
