## Technical Service Bulletin (TSB)

### Flash: Electronic Vehicle Control Unit (EVCU) Updates

| REFERENCE: | TSB: 08-075-25<br>GROUP: 08 - Electrical | Date: | March 20, 2025 | REVISION: | — |
| VEHICLES AFFECTED: | 2024 (LB) Dodge Charger<br>This bulletin applies to vehicles equipped with 400V G2500 FR/RR Elec Drive Motors (Sales Code ELD). | | | MARKET APPLICABILITY:<br><div><input checked="" type="checkbox"/> NA<input checked="" type="checkbox"/> MEA</div> <div><input checked="" type="checkbox"/> SA<input checked="" type="checkbox"/> IAP</div> <div><input checked="" type="checkbox"/> EE<input checked="" type="checkbox"/> CH</div> | |

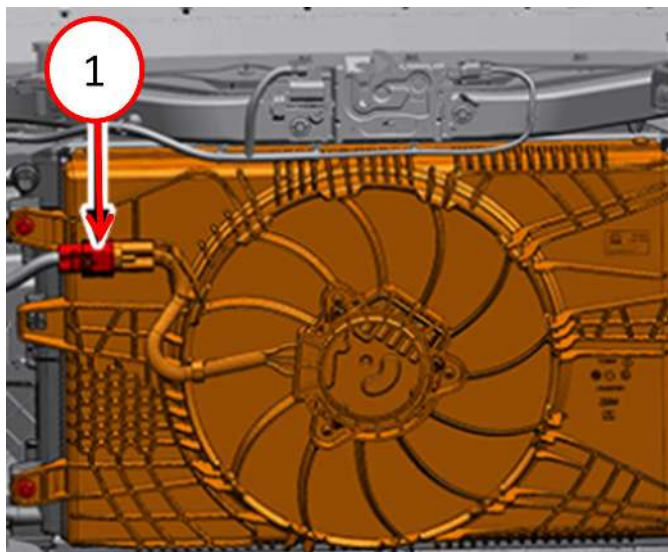
**Fig. 1**  
Cooling Fan Assembly

1 - Wire Harness To Disconnect/Connect

4. Disconnect the cooling fan wire harness connector [Fig. 1](#).

21. Connect the cooling fan wire harness connector [Fig. 1](#).
