**SUBARU.****QUALITY DRIVEN® SERVICE****SERVICE BULLETIN****APPLICABILITY:** 2015-21MY WRX/STI 2.5L Turbo MT**NUMBER:** 09-131-25**SUBJECT:** Diagnosis Procedures for DTCs P2404 & P0420**DATE:** 03/04/25**INTRODUCTION:**

This bulletin announces the diagnostic procedures and availability of reprogramming files to rectify the following Diagnostic Trouble Codes (DTCs).

- P2404: EVAP System Leak Detection Pump Sense Circuit Range/Performance.
- P0420: Catalyst System Efficiency Below Threshold Bank 1. (not applicable for 15-18 models)

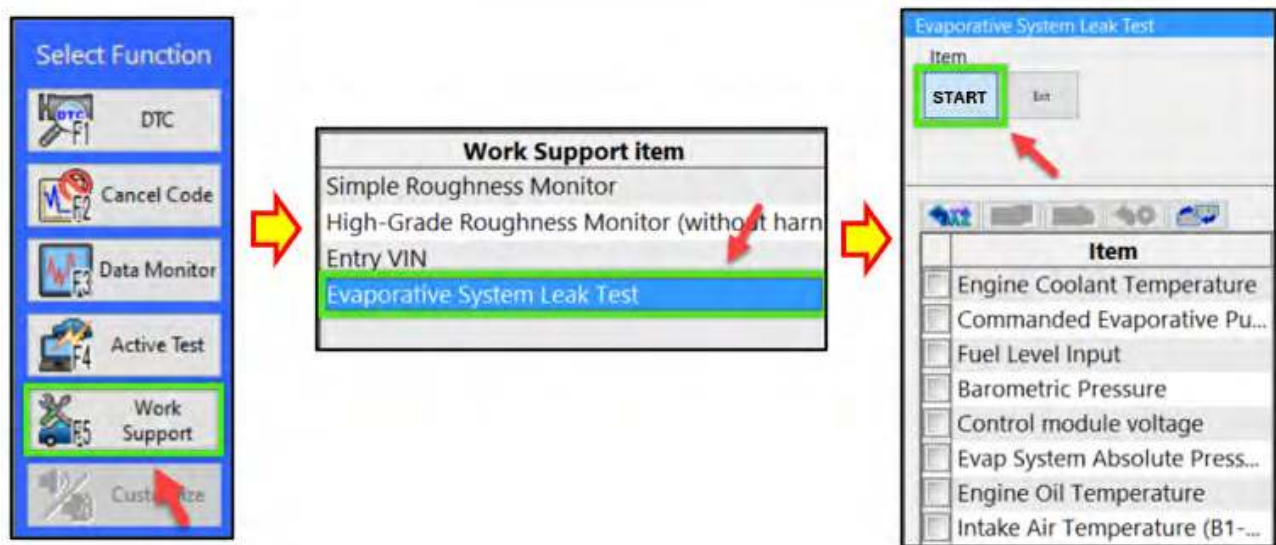
Once the evaporative system leak test is complete, check the DTCs and examine the vacuum value results. Record the value shown in the row labeled MID: \$3C, TID: \$C4, and Scaling ID: \$FE. This value should be lower than -0.26 PSI.

**STEP 4:** Connect the vehicle to a recommended power supply. See APPENDIX A for addition information regarding power supply. Using SSM, perform the Evaporative System Leak Test. Collect and save all data.
