## Technical Service Bulletin (TSB)

### No Start, Loose Ground

| REFERENCE: | TSB: 08-089-25<br>GROUP: 08 - Electrical | Date: | March 28, 2025 | REVISION: | — |
| VEHICLES AFFECTED: | 2024 (GG) Dodge Hornet<br>This bulletin applies to vehicles built on or before June 07, 2024 (MDH 0607XX) equipped with a 2.0L I4 DOHC DI Turbo Engine w/ESS (Sales Code EC1). | | | MARKET APPLICABILITY:<br><div><input checked="" type="checkbox"/> NA<input type="checkbox"/> MEA<br/><input type="checkbox"/> SA<input type="checkbox"/> IAP<br/><input type="checkbox"/> EE<input type="checkbox"/> CH</div> | |

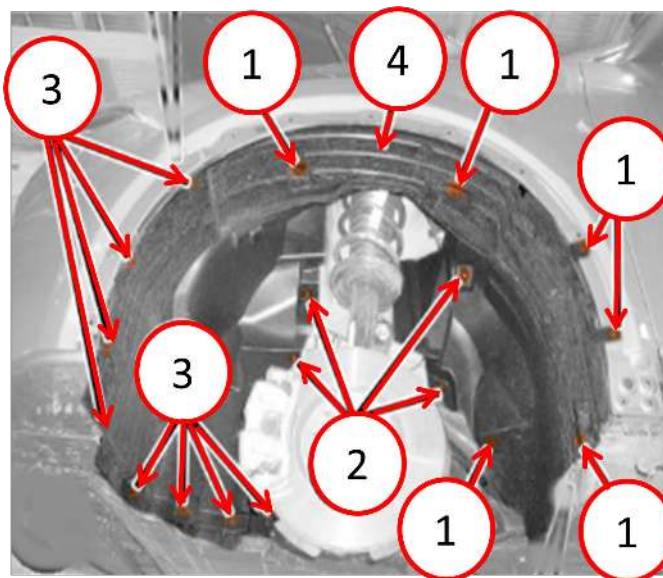
**Fig. 1**

Left Front Splash Shield Fasteners, Nuts And Screws

- 1 - Retaining Buttons
- 2 - Nuts
- 3 - Screws
- 4 - Splash Shield

3. Remove the left front splash shield fasteners, nuts and screws from the splash shield [Fig. 1](#).

5. Install the left front splash shield fasteners, nuts and screws [Fig. 1](#). Tighten all screw and nut fasteners securely.
6. Install the left tire and wheel assembly. Refer to the detailed procedures available in DealerCONNECT > Service Library> under: 22 - Tires and Wheels / Installation.
7. Lower the vehicle.
8. Clear all DTCs that may have been set.

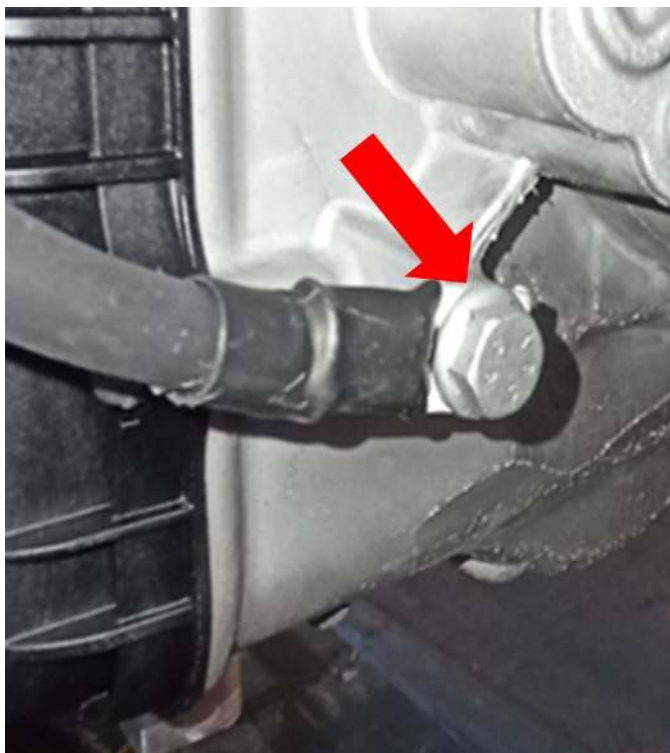
**Fig. 2**  
G902A Ground Bolt

| CAUSE: | Ground issue | | | | |

This bulletin involves replacing the G902A ground bolt.

4. Replace the G902A ground bolt [Fig. 2](#). Tighten the bolt to 15 N·m (11 Ft. Lbs.).
