**Technical Service Bulletin (TSB)**  
**Service Hybrid Electric Vehicle System Warning Message**

| REFERENCE: | TSB: 08-116-25<br>GROUP: 08 - Electrical | Date: | April 12, 2025 | REVISION: | — |
| VEHICLES AFFECTED: | 2023 - 2025 (JL) Jeep Wrangler<br>This bulletin applies to vehicles built on and before October 14, 2024 (MDH 1014XX) equipped with 2.0L I4 DOHC DI Turbo Engine W/ESS (Sales Code ECX). | | | MARKET APPLICABILITY:<br><div><input checked="" type="checkbox"/> NA<input type="checkbox"/> MEA<br/><input type="checkbox"/> SA<input type="checkbox"/> IAP<br/><input type="checkbox"/> EE<input type="checkbox"/> CH</div> | |

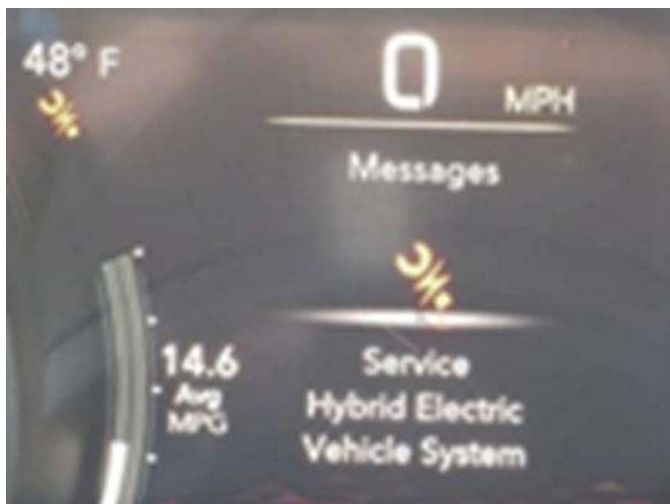
| CUSTOMER SYMPTOM: | Customers must experience a Malfunction Indicator Lamp (MIL) illumination and the vehicle must exhibit/set the following Diagnostic Trouble Code (DTC): <ul style="list-style-type: none"><li>B273C-00 - Digital Crash Input.</li></ul> NOTE: Technicians may find the DTC is stored or pending in the Hybrid Control Processor (HCP).<br>Customers may experience one or more of the following: <ul style="list-style-type: none"><li>The "Service Hybrid Electric Vehicle System Warning" message and Light are displayed in the Instrument Panel Cluster (IPC) <a href="#">Fig. 1</a>.<br/>NOTE: This message may be displayed for a few seconds and then disappear.</li><li>The vehicle may no longer enter Electric or Hybrid drive modes.</li></ul> | | | | |
| CAUSE: | Electromagnetic noise on R414 circuit | | | | |

**Fig. 1**  
Service Hybrid Electric Vehicle System Warning IPC Message

This bulletin involves installing a ferrite bead to the high voltage battery body harness.

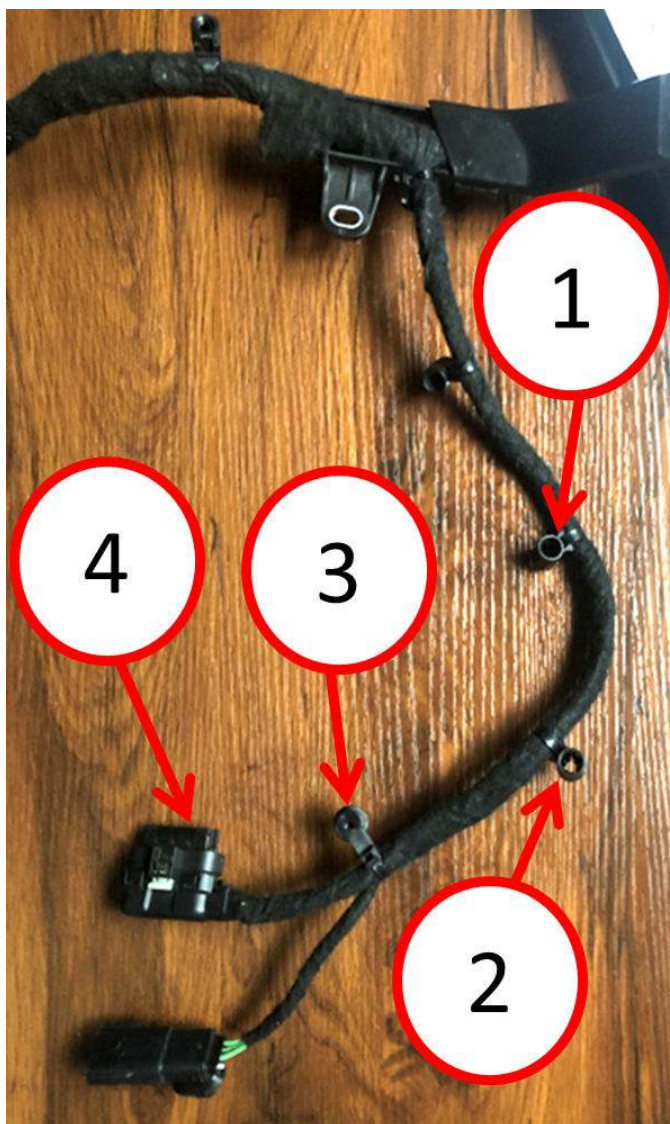
**Fig. 2**

High Voltage Battery Connectors Body Harness

- 1 - Clip 1106
- 2 - Stud Clip 1107
- 3 - Offset Clip 1108
- 4 - Connector D8119E

6. Remove the cover on D8119E connector [Fig. 2](#).
7. Remove offset clip 1108 [Fig. 2](#) from wire harness.
8. Remove stud clip 1107 [Fig. 2](#) from wire harness.

9. Remove harness protective tape from D8119E to the remaining stud clip 1106 [Fig. 2](#) from wire harness.
10. Locate R414A in cavity 16, located in connector D8119E [Fig. 2](#) and remove the dark green/beige circuit wire [Fig. 3](#).

14. Using a heat gun, heat the heat shrink tubing around ferrite bead, ensuring sealant flows out of each end tubing [Fig. 3](#).
15. Install wire circuit R414A back into connector D8119E [Fig. 2](#) cavity 16.

16. Install conduit from kit over ferrite bead assembly.
17. Install protective tape from D8119E over ferrite bead conduit and to clip 1106.
18. Install a new clip 1107 103 mm (4.0 in.) from clip 1106 [Fig. 2](#).

19. Install a new clip 1108 90 mm (3.5 in.) from clip 1107 [Fig. 2](#).
20. Install the D8119E connector cover [Fig. 2](#).
21. Install the high battery voltage closeout panel. Refer to the detailed procedures available in DealerCONNECT > Service Library> under: 23 - Body / Interior / Panel, High Voltage Battery Closeout / Installation.

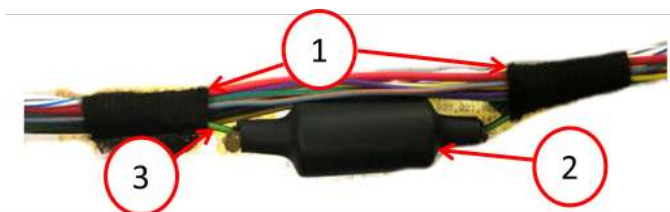
**Fig. 3**  
Ferrite Bead Assembly

- 1 - Butyl Patches
- 2 - Ferrite Bead With Heat Shrink
- 3 - Dark Green/Beige Wire

11. Place circuit R414A through the ferrite bead and slide the ferrite bead [Fig. 3](#) to approximately 25 mm (0.98 in.) from where clip 1106 was originally located [Fig. 2](#).

12. Install two butyl patches around wire circuit R414A at both openings of the ferrite bead [Fig. 3](#).
13. Place Heat Shrink tube over circuit R414A and ferrite bead [Fig. 3](#).
