## Technical Service Bulletin (TSB)

### Improperly Installed Wastegate Rod Retention Clips

| REFERENCE: | TSB: 09-008-25<br>GROUP: 09 - Engine | Date: | April 16, 2025 | REVISION: | — |
| VEHICLES AFFECTED: | 2025 (DT) RAM 1500 Pickup<br>This bulletin applies to vehicles built on or after June 01, 2024 (MDH 0601XX) and on or before March 03, 2025 (MDH 0325XX) equipped with the 3.0L I6 Hurricane HO Twin Turbo ESS (Sales Code EFC). | | | MARKET APPLICABILITY:<br><div><input checked="" type="checkbox"/> NA<input type="checkbox"/> MEA<br/><input type="checkbox"/> EE<input type="checkbox"/> IAP<br/><input type="checkbox"/> SA<input type="checkbox"/> CH</div> | |

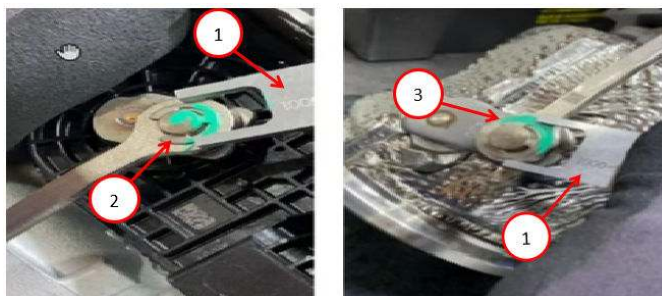
**Fig. 1**  
Wastegate Rod Retaining Clips

| CAUSE: | Incorrectly installed wastegate rod retention clips | | | | |

- 1 - Measuring Tool  
2 - Actuator Side Wastegate Rod Retaining Clip  
3 - Housing Side Wastegate Rod Retaining Clip

1. Remove the clean air tube. Refer to the detailed service procedures available in DealerCONNECT/Service Library under: Service Info> 09 - Engine, 3.0L GMET6 / Air Intake System / Tube, Intake Air / Removal.
2. Using a caliper, measure the dimensions of the two wastegate rod retaining clips on the actuator side [Fig. 1](#).

3. Is the measurement of either wastegate rod retaining clip on the actuator side greater than 13.70 mm (0.5 in.)?
  - YES>>> Proceed to [Step 4](#).
  - NO>>> Proceed to [Step 5](#).
4. Replace any wastegate rod retaining clip on the actuator side that measures larger than 13.70 mm (0.5 in.).

5. Using a caliper, measure the dimensions of the two wastegate rod retaining clips on the housing side [Fig. 1](#).
6. Is the measurement of either of the wastegate rod retaining clips on the housing side greater than 17.78 mm (0.7 in.)?
  - YES>>> Proceed to [Step 7](#).
  - NO>>> This bulletin has been completed, use Inspect LOP (09-44-03-92) to close this active RSU and proceed to [Step 8](#).
7. Replace any wastegate rod retaining clip on the housing side that measures larger than 17.78 mm (0.7 in.).
8. Install the clean air tube. Refer to the detailed service procedures available in DealerCONNECT/Service Library under: Service Info> 09 - Engine, 3.0L GMET6 / Air Intake System / Tube, Intake Air / Installation.
9. Clear DTCs.
