## M274 Check engine light, P052E71 Crankcase ventilation valve

| Topic number | LI01.20-P-076894 |
| Function group | 01.20 - Crankcase ventilation, cylinder head cover |
| Validity | Passenger car with engine M274 |

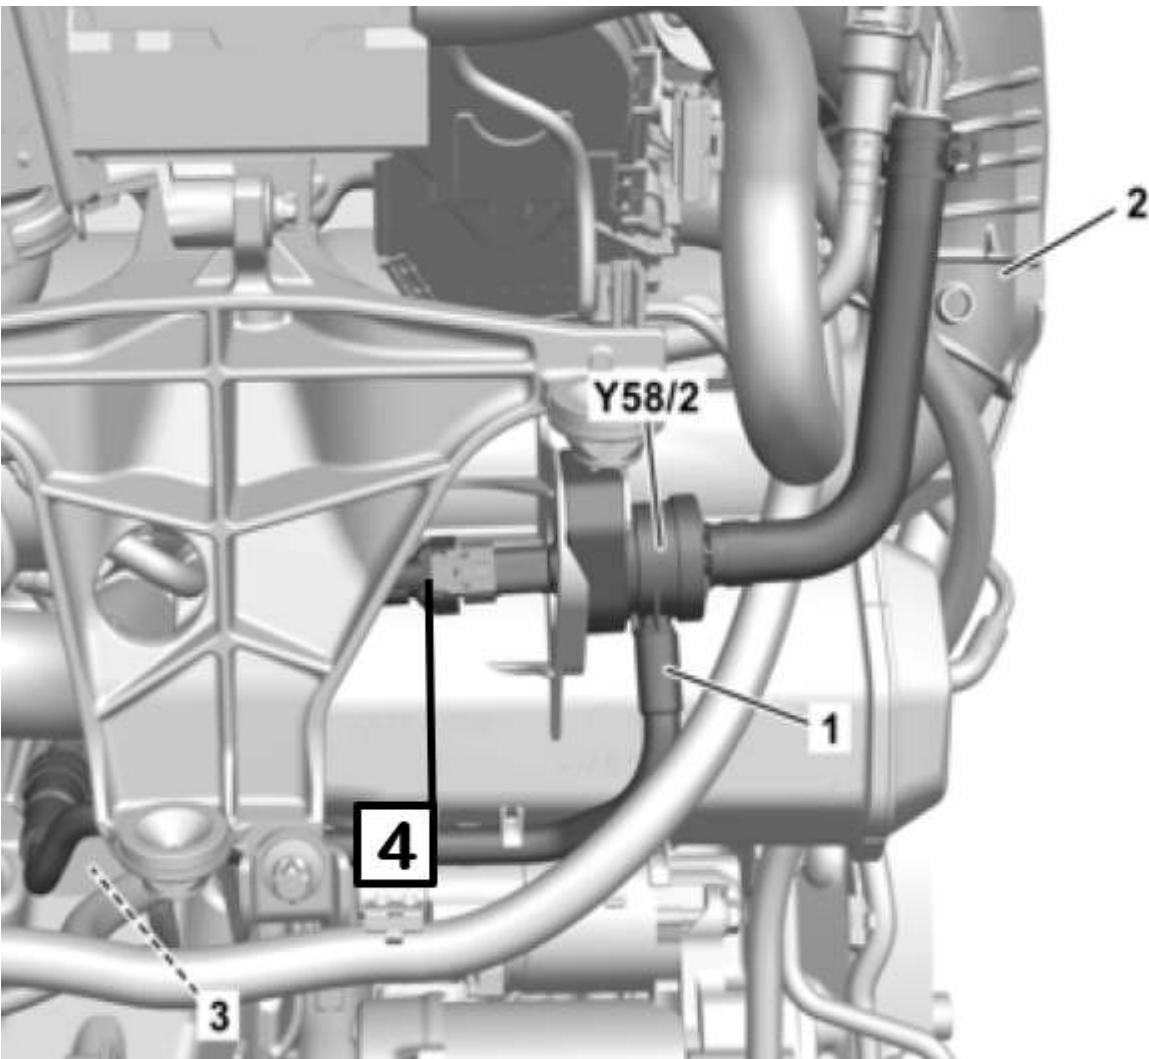
Fault code stored in N3/10 control unit- P052E71 – Positive Crankcase Ventilation Regulator Valve Performance: The valve for crankcase ventilation has a malfunction

The partial-load ventilation valve (a part of the intake line assembly) may not work as intended.

- 1- Perform software update for N3/10 Engine control unit.
- 2- Remove upper engine cover.
- 3- Unclip ME-SFI control unit (N3/10) with bracket and place to one side with connected lines (see AR07.08-P-7013M-RD).
- 4- Release and disconnect electrical connector (4) of partial-load operation crankcase ventilation valve (Y58/2).
- 5- Fit cap A094 545 50 03 on electrical connector (4) of engine wiring harness partial load operation crankcase ventilation valve (Y58/2) and ensure correct seating on plug of electrical connector (4).

6- Strap down electrical line (4) of partial load operation crankcase ventilation system valve (Y58/2) at wiring harness. Ensure that electrical line (4) is routed free of tension.
