## Technical Service Bulletin (TSB)

### Multiple Systems Repair Bundle Campaign

| REFERENCE: | TSB: 23-019-25<br>GROUP: 23 - Body | Date: | April 22, 2025 | REVISION: | — |
| VEHICLES AFFECTED: | 2025 (JL) Jeep Wrangler<br>This bulletin applies to vehicles built on or after July 01, 2024 (MDH 0701XX) and on or before February 28, 2025 (MDH 0228XX). | | | MARKET APPLICABILITY:<br><div><input type="checkbox"/> NA<input type="checkbox"/> MEA</div> <div><input type="checkbox"/> SA<input checked="" type="checkbox"/> IAP</div> <div><input type="checkbox"/> EE<input type="checkbox"/> CH</div> | |

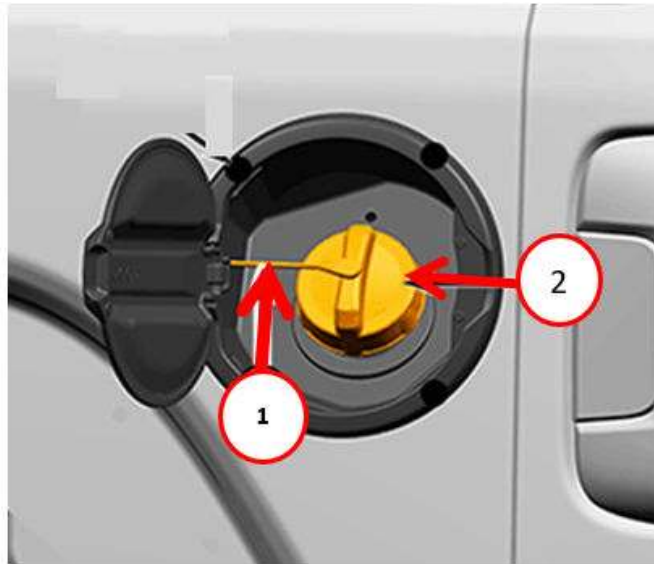
**Fig. 1**  
Fuel Cap Replacement

13. Is the fuel cap tether strap broken?

14. Remove the fuel cap tether strap fastener securing the strap to the fuel door housing [Fig. 1](#).

15. Replace the fuel cap tether strap and the fuel cap assembly.
