**Technical Service Bulletin (TSB)**  
**RSU With Additional Sleep Cycles for HV Battery Integrity**  
**Check - Flash: Motor Control Processor B (MCP B) Updates 6A1**

| REFERENCE: | TSB: 08-080-25 REV. A<br>GROUP: 08 - Electrical | Date: | April 29, 2025 | REVISION: | 08-080-25 |
| VEHICLES AFFECTED: | 2025 (LB) Dodge Charger<br>This bulletin applies to vehicles built on and before **April 03, 2025 (MDH 0403XX)** equipped with 400V G2500 FR/RR Elec Drive Motors (Sales Code ELD). | | | MARKET APPLICABILITY:<br><div><input checked="" type="checkbox"/> NA<input checked="" type="checkbox"/> MEA<br/><input checked="" type="checkbox"/> SA<input checked="" type="checkbox"/> IAP<br/><input checked="" type="checkbox"/> EE<input checked="" type="checkbox"/> CH</div> | |

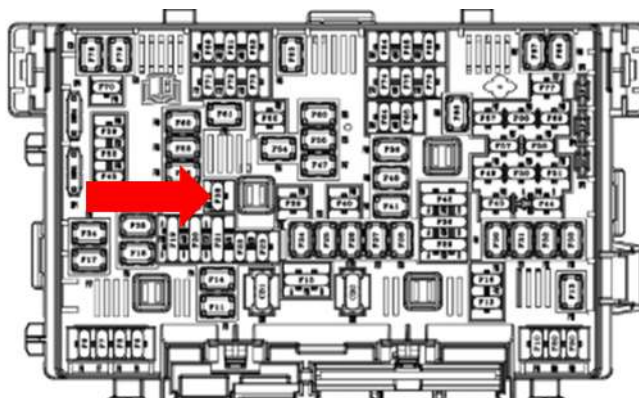
**Fig. 3**  
#38 AGSM Fuse Location

**Failure to remove the #38 AGSM fuse will result in damage to the shifter.**

6. Remove the PDC cover, locate and remove the #38 AGSM fuse [Fig. 3](#).\*\*

24. \*\*Install the #38 AGSM fuse [Fig. 3](#) and the PDC cover [Fig. 2](#).
