**Technical Service Bulletin (TSB)**  
**RSU With Additional Sleep Cycles for HV Battery Integrity**  
**Check - Flash: Motor Control Processor A (MCP A) Updates 6A1**

| REFERENCE: | TSB: 08-079-25 REV. A<br>GROUP: 08 - Electrical | Date: | April 29, 2025 | REVISION: | 08-079-25 |
| VEHICLES AFFECTED: | 2025 (LB) Dodge Charger<br>This bulletin applies to vehicles built on or before **April 03, 2025 (MDH 0403XX)** equipped with a 400V G2500 FR/RR Elec Drive Motors (Sales Code ELD). | | | MARKET APPLICABILITY:<br><div><input checked="" type="checkbox"/> NA<input checked="" type="checkbox"/> MEA<br/><input checked="" type="checkbox"/> SA<input checked="" type="checkbox"/> IAP<br/><input checked="" type="checkbox"/> EE<input checked="" type="checkbox"/> CH</div> | |

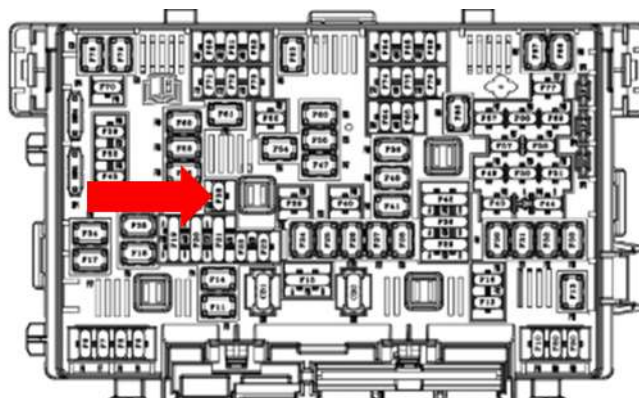
**Fig. 3**  
#38 AGSM Fuse Location

**Failure to remove the #38 AGSM fuse will result in damage to the shifter.**

6. Remove the PDC cover, locate and remove the #38 AGSM fuse [Fig. 3](#).\*\*

24. \*\*Install the #38 AGSM fuse [Fig. 3](#) and the PDC cover [Fig. 2](#).
