**Technical Service Bulletin (TSB)**  
**RSU With Additional Sleep Cycles for HV Battery Integrity Check**  
**- Flash: Electronic Vehicle Control Unit (EVCU) Updates 11A1**

| REFERENCE: | TSB: 08-074-25 REV. A<br>GROUP: 08 - Electrical | Date: | April 29, 2025 | REVISION: | 08-074-25 |
| VEHICLES AFFECTED: | 2024 (KM) Jeep Wagoneer S<br>This bulletin applies to vehicles equipped with 400V G2500 FR/RR Elec Drive Motors (Sales Code ELD). | | | MARKET APPLICABILITY:<br><div><input type="checkbox"/> NA<input type="checkbox"/> **IAP**<br/><input type="checkbox"/> **SA**<input type="checkbox"/> **CH**<br/><input type="checkbox"/> **EE**<br/><input type="checkbox"/> **MEA**</div> | |

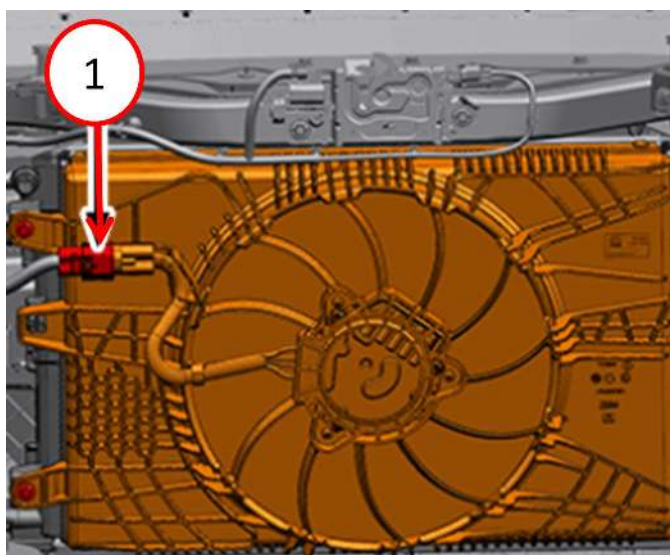
**Fig. 1**  
Cooling Fan Assembly

1 - Wire Harness To Disconnect/Connect

4. Disconnect the cooling fan wire harness connector [Fig. 1](#).

22. Connect the cooling fan wire harness connector [Fig. 1](#).
