## Technical Service Bulletin (TSB)

### RSU With Additional Sleep Cycles for HV Battery Integrity Check - Flash: Electronic Vehicle Control Unit (EVCU) Updates 6A1

| REFERENCE: | TSB: 08-073-25 REV. A<br>GROUP: 08 - Electrical | Date: | April 29, 2025 | REVISION: | 08-073-25 |
| VEHICLES AFFECTED: | 2025 (LB) Dodge Charger<br>This bulletin applies to vehicles **built on or before April 03, 2025** equipped with 400V G2500 FR/RR Elec Drive Motors (Sales Code ELD). | | | MARKET APPLICABILITY:<br><input checked="" type="checkbox"/> NA<br><input checked="" type="checkbox"/> SA<br><input checked="" type="checkbox"/> EE<br><input checked="" type="checkbox"/> MEA<br><input checked="" type="checkbox"/> IAP<br><input checked="" type="checkbox"/> CH | |

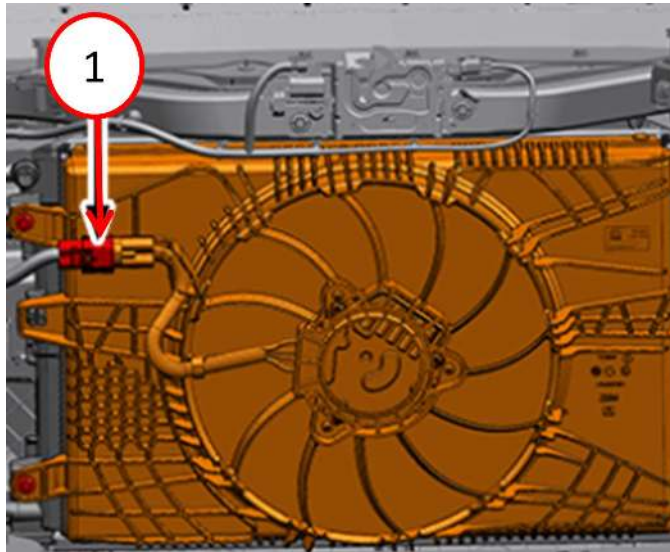
**Fig. 1**  
Cooling Fan Assembly

1 - Wire Harness To Disconnect/Connect

4. Disconnect the cooling fan wire harness connector [Fig. 1](#).

26. Connect the cooling fan wire harness connector [Fig. 1](#).

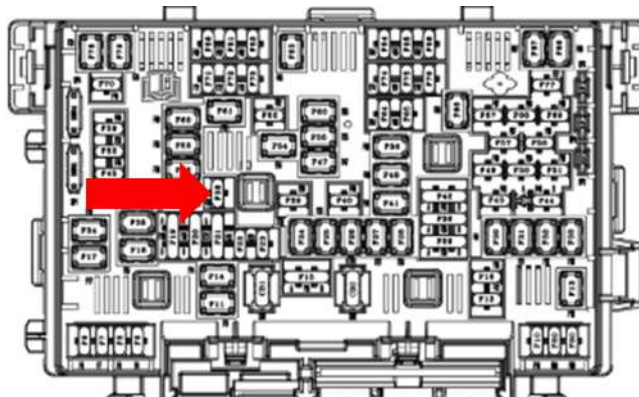
**Fig. 3**  
#38 AGSM Fuse Location

**Failure to remove the #38 AGSM fuse will result in damage to the shifter.**

6. Remove the PDC cover, locate and remove the #38 AGSM fuse [Fig. 3](#).\*\*

24. \*\*Install the #38 AGSM fuse [Fig. 3](#) and the PDC cover [Fig. 2](#).
