## Technical Service Bulletin (TSB)

### Flash: Motor Control Processor B (MCP B) Updates 11A1

| REFERENCE: | TSB: 08-013-25 REV. B<br>GROUP: 08 - Electrical | Date: | April 29, 2025 | REVISION: | 08-013-25 REV. A |
| VEHICLES AFFECTED: | 2024 (KM) Jeep Wagoneer S<br>This bulletin applies to vehicles equipped with 400V G2500 FR/RR Elec Drive Motors (Sales Code ELD). | | | MARKET APPLICABILITY:<br><div><input type="checkbox"/> NA<input type="checkbox"/> MEA</div> <div><input type="checkbox"/> **SA<input type="checkbox"/> IAP</div> <div><input type="checkbox"/> EE<input type="checkbox"/> CH**</div> | |

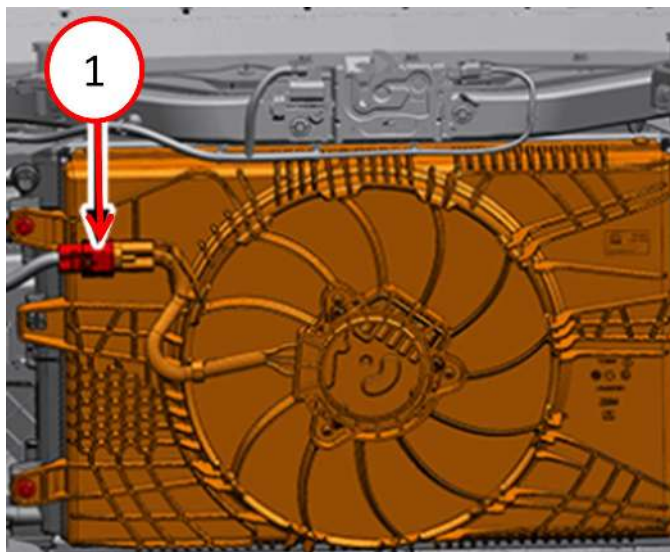
**Fig. 1**  
Cooling Fan Assembly

1 - Wire Harness To Disconnect/Connect

4. Disconnect the cooling fan wire harness connector [Fig. 1](#).\*\*

22. \*\*Connect the cooling fan wire harness connector [Fig. 1](#).
