| REFERENCE: | TSB: 08-011-25 REV. B<br>GROUP: 08 - Electrical | Date: | April 29, 2025 | REVISION: | 08-011-25 REV. A |
| VEHICLES AFFECTED: | 2024 (KM) Jeep Wagoneer S<br>This bulletin applies to vehicles equipped with 400V G2500 FR/RR Elec Drive Motors (Sales Code ELD). | | | MARKET APPLICABILITY:<br><div><input type="checkbox"/> NA<input type="checkbox"/> **IAP**<br/><input type="checkbox"/> **SA**<input type="checkbox"/> **CH**<br/><input type="checkbox"/> **EE**<br/><input type="checkbox"/> **MEA**</div> | |

| <b>CAUSE:</b> | <b>BPCM software update</b> |

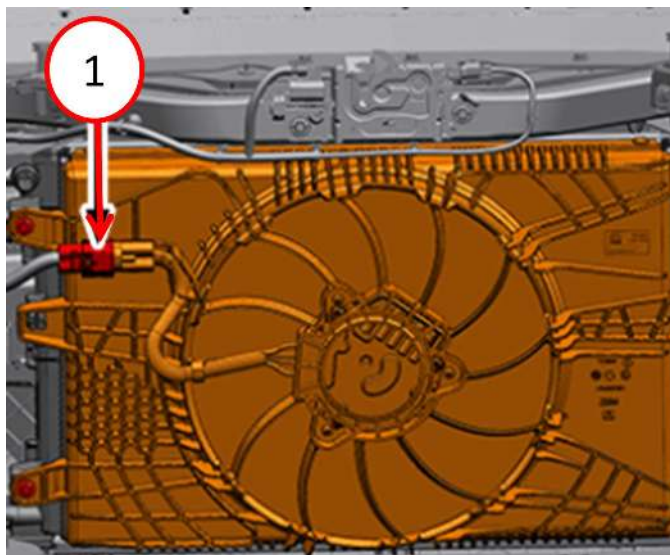
**Fig. 1**  
Cooling Fan Assembly

1 - Wire Harness To Disconnect/Connect

4. Disconnect the cooling fan wire harness connector [Fig. 1](#).

22. Connect the cooling fan wire harness connector [Fig. 1](#).
